State of Oregon
Department of
Environmental
Quality

LANDFILL INSPECTION REPORT

FACILITY:	Riverbend Landfill		
COUNTY:	Yamhill	PERMIT NO:	345
INSPECTOR(S):	Bob Schwarz	INSPECTION DATE:	Jan 14, 2014
	Start time:	8:30 am	End time: noon
Site Weather Conditions: Partly cloudy, 34 F			
Facility Representatives:	Tim Watson		
Inspection type:	Unannounced landfill inspection		
Facility Type:	MSW Landfill

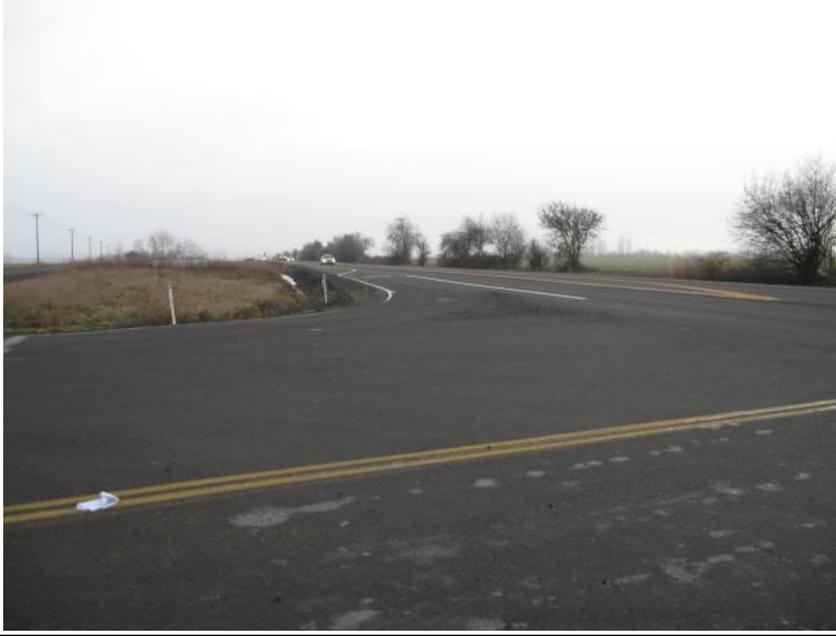
1. Highway 18 viewed from Masonville Road, looking northeast.

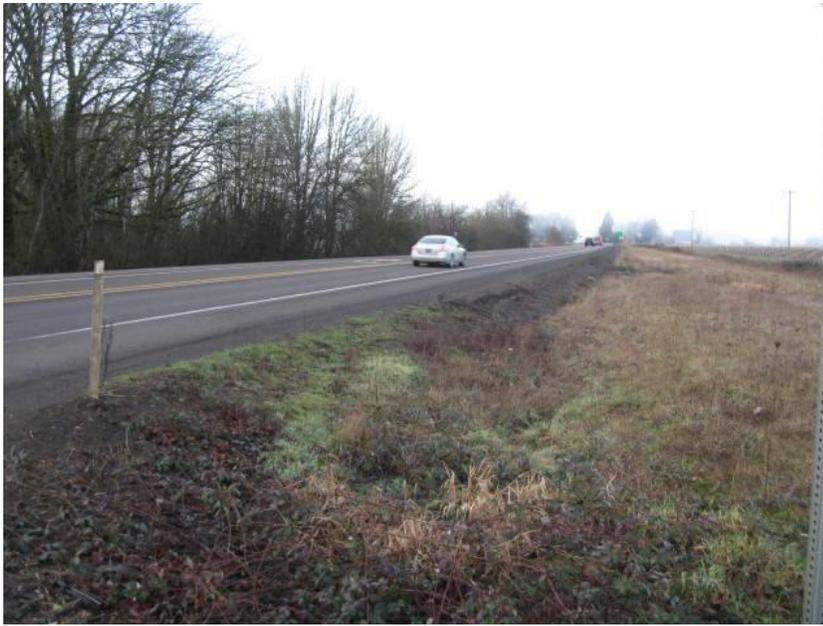
2. Highway 18 and eastern drainage swale, looking northeast from point near northern extent of Waste Management property.

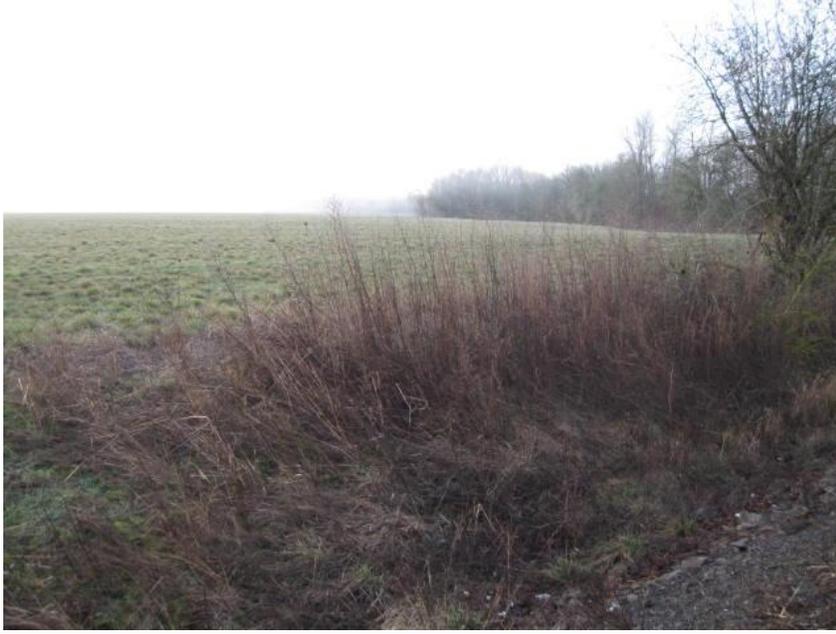
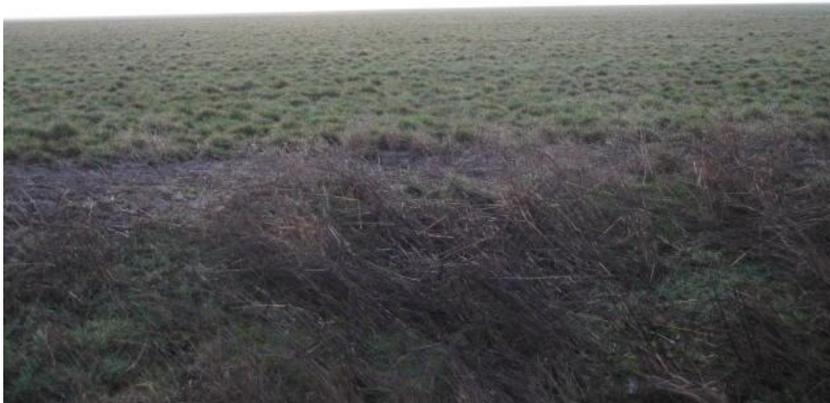
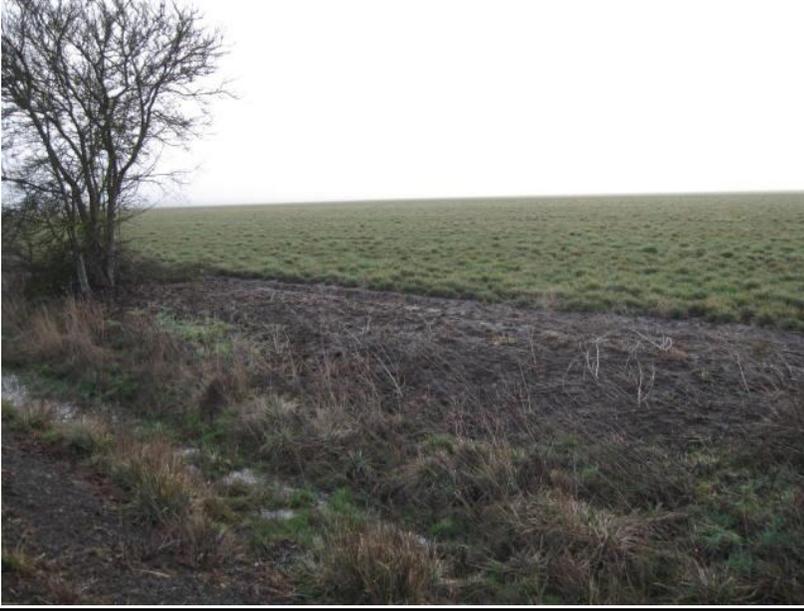
Litter and birds. I drove north along Highway 18 from the landfill prior to entering the site to assess the amount of litter on and along the side of the road. I did see some litter most of the way. DEQ has received complaints recently of a large amount of roadside litter near the landfill. I then drove along back roads west of the landfill and observed litter there as well. This included blowable litter, such as plastic bags, which could have come from the landfill or trucks. I also observed steel cans and other debris, which presumably are not from the landfill. I then proceeded further north on Highway 18. North of the junction with 99, the roads had less litter because a litter pickup had been done recently. Bags of litter were placed along the roadway for pickup. Neighbor Ramsey McPhillips has complained recently of an increase in litter, birds and rats on his property. I did observe approximately 80 seagulls on that portion of his land that I could see from the highway. I did not see litter on his property. See photos 3, 4 and 5.

3. View of field on McPhillips property, from Highway 18.

4. View of field on McPhillips property, from Highway 18.

5. View of field on McPhillips property, from Highway 18.

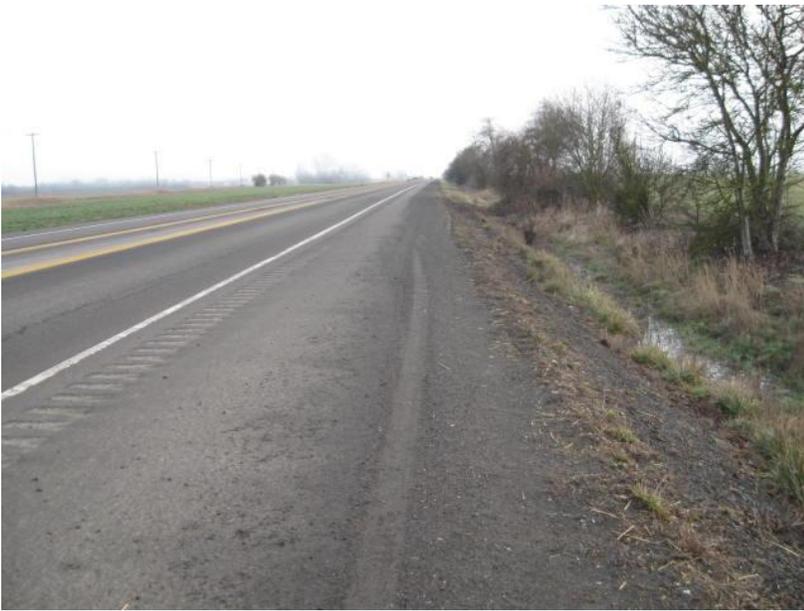
Erosion and sediment controls. Highway 18 looked fairly clean (very little mud or stones). See photos 1,2, 6 and 7. This differs from observations of at least two neighbors, who recently complained of mud on the roads and dust kicked up by trucks driving over the mud. A neighbor complained of a large cloud of dust on the road during the same time that I was conducting this inspection. I did not observe dust clouds over the road.

6. Highway 18 and eastern drainage swale, looking northeast from point adjacent to McPhillips property.

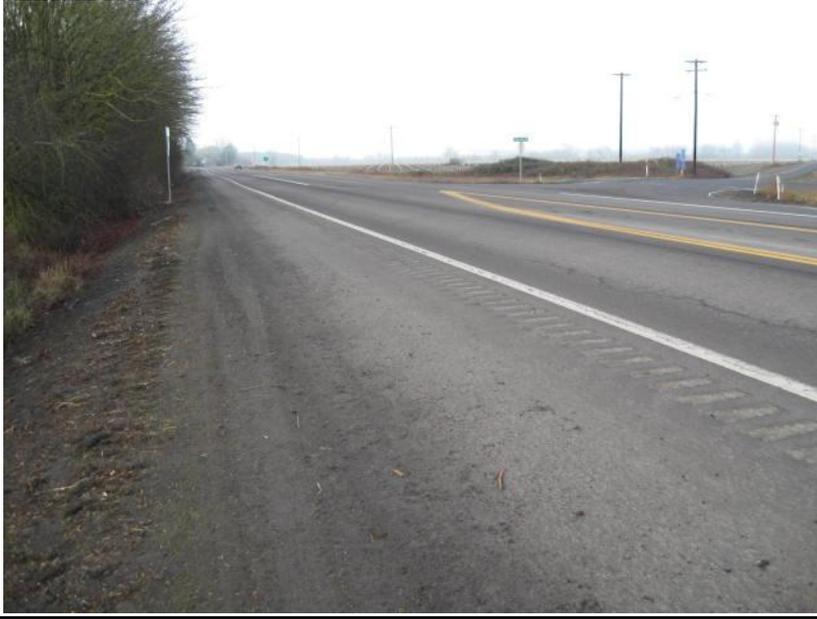
7. View of Highway and Masonville Road, looking southwest.

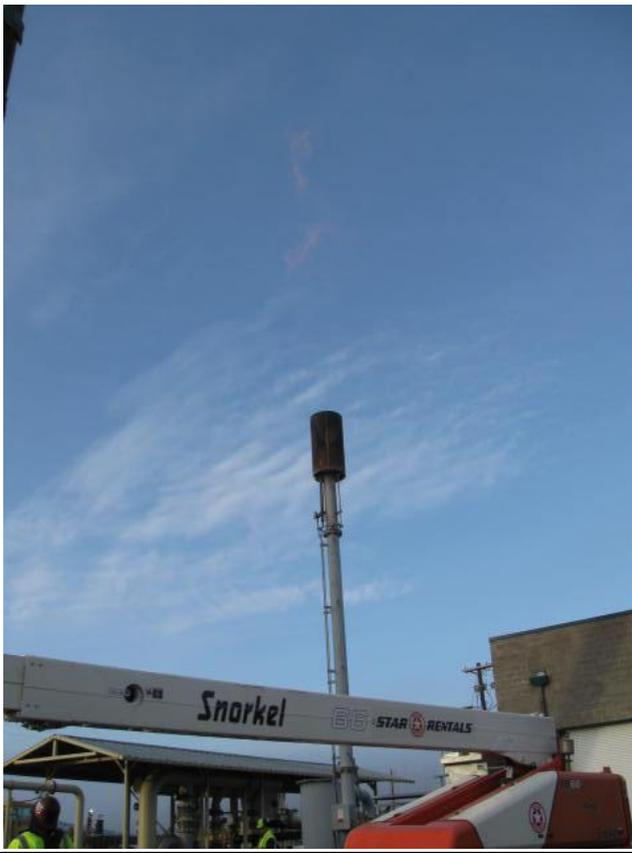
Gas flare. The landfill's enclosed flare has been down for repairs. Repair personnel were onsite today. The flare has a vertical wall that divides it into a large and small chamber, to enable it to work efficiently at large and small gas loading rates. This vertical wall appears to have been damaged, possibly due to heat. Pieces of this wall were removed during my observation. One member of the repair crew told me the problem could be that portions of the wall had fallen on some of the gas burners. Waste Management brought in a candlestick flare for use in the meantime. This is shown in photo 8. The landfill has received several complaints that the landfill is on fire. This is presumably because this replacement flare has an open flame, unlike the landfill's regular flare. The flame is very

8. Candlestick flare brought to the site because the site's enclosed flare is down for maintenance. The flame is somewhat visible above the unit.

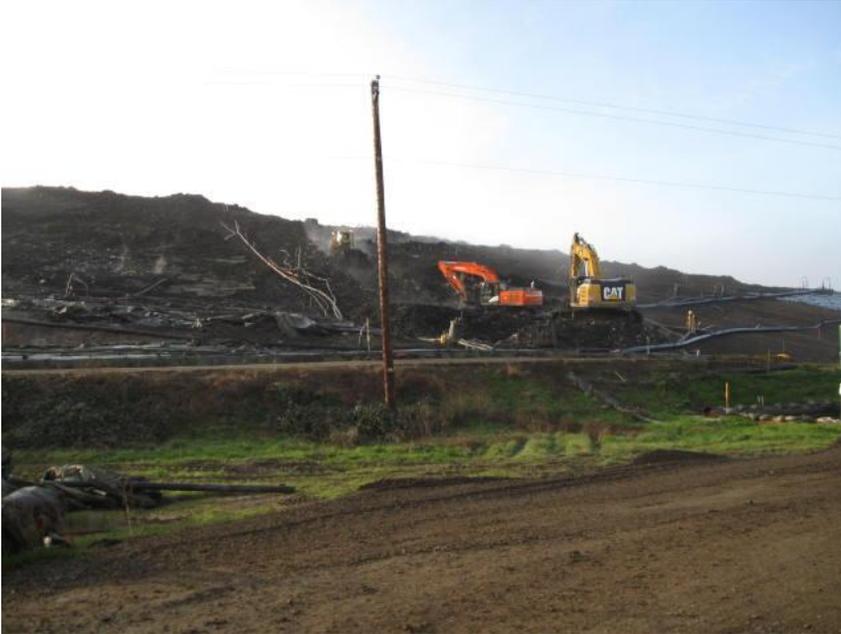
9. Relocation of waste along north slope. This is being done partly for construction of the north access road and partly to accommodate the revised grades associated with the northern portion of the MSE berm.

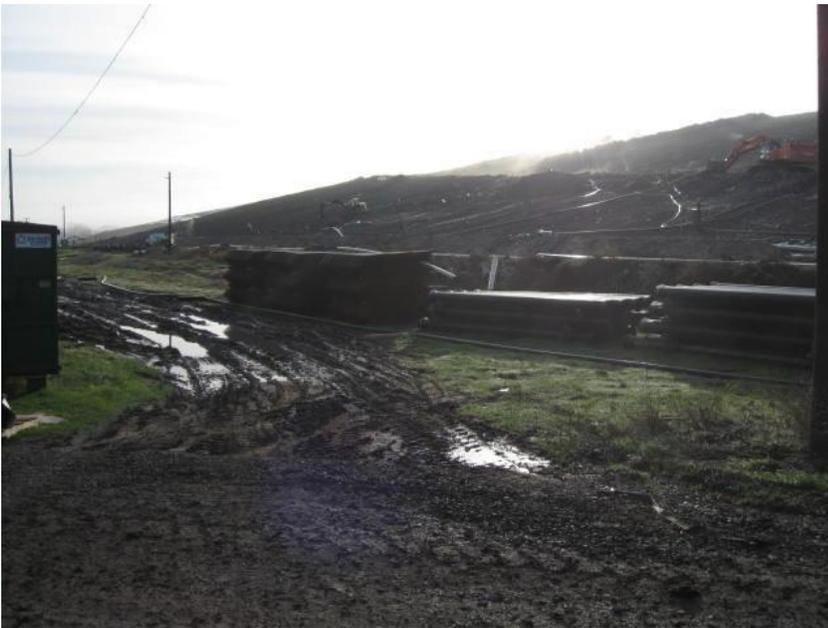
10. Another view of north slope of landfill.

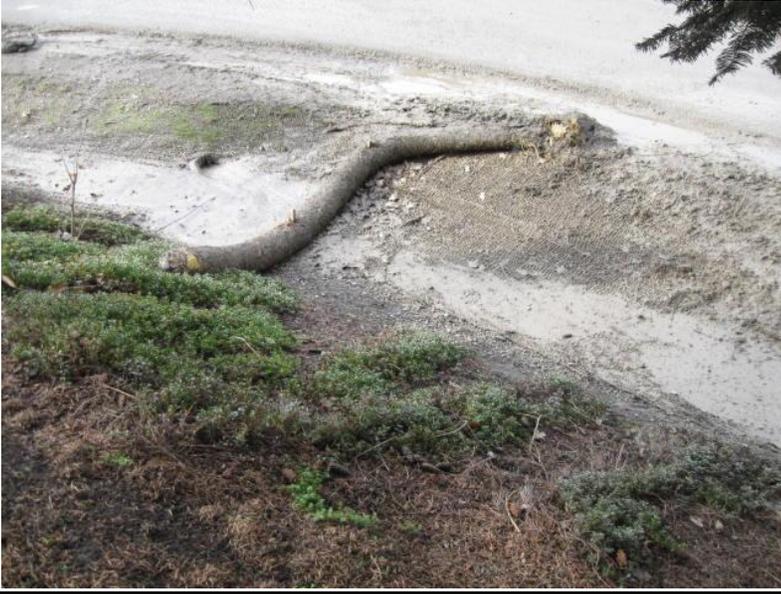
The wattles (photo 11) used to collect sediment along the side of the Highway 18 are not working as well as intended. Some mud is passing under them. Contractor said today that these will be replaced with aggregate check dams.

11. Wattle (netting filled with mulch) to block sediment and reduce velocity of stormwater. As shown, some sediment is passing under the wattles. The contractor plans to replace these with aggregate (rock) check dams. These will therefore be replaced with aggregate (rock) check dams.

38.	Stormwater Drainage Structures. Pipes, culverts, ditches, swales, berms, dikes, straw bales, erosion control matting, riprap, and other structures are well maintained, constructed per DEQ-approved design plans and specifications?	x			
Notes: Some mud is getting under wattles placed in drainage swale along highway. Contractor noted that they will replace these with gravel check dams.

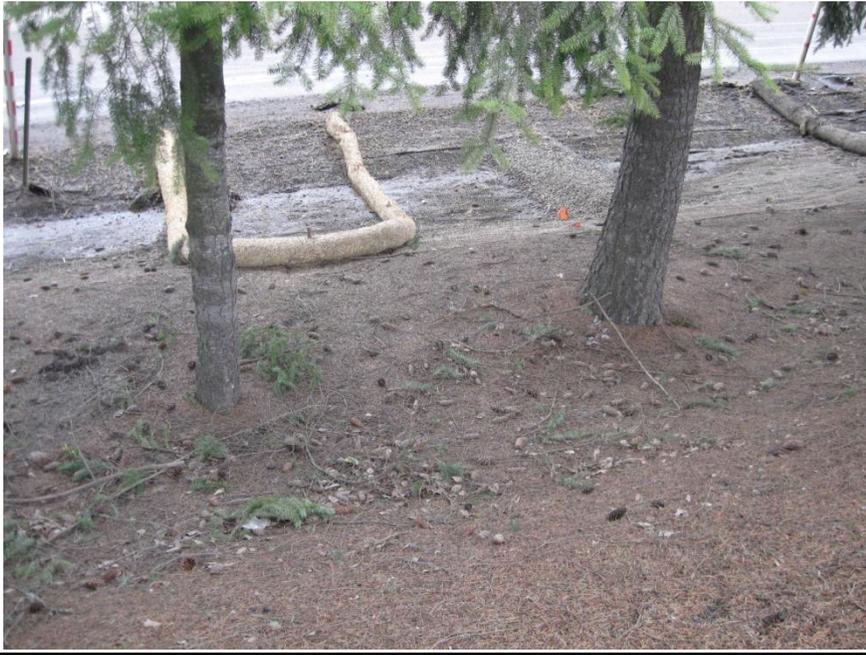
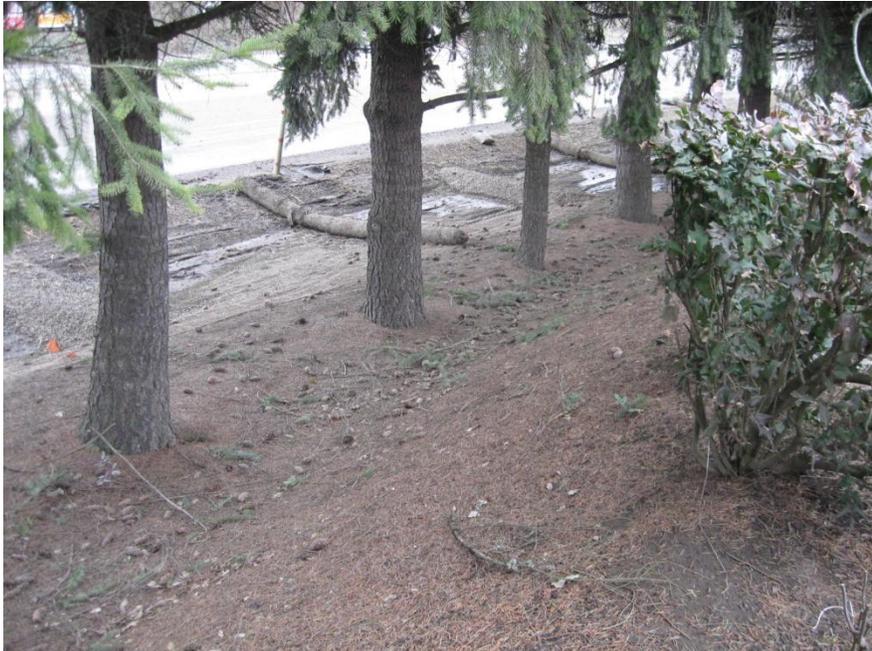
1. New stormwater wattles and gravel check dams in swale along Highway 18.

2. New stormwater wattles and gravel check dams in swale along Highway 18.

38.	Stormwater Drainage Structures. Pipes, culverts, ditches, swales, berms, dikes, straw bales, erosion control matting, riprap, and other structures are well maintained, constructed per DEQ-approved design plans and specifications?	x			
Notes: Wattles along Highway 18 have been replaced and supplemented with gravel check dams. These appear to be more effective at catching sediment.

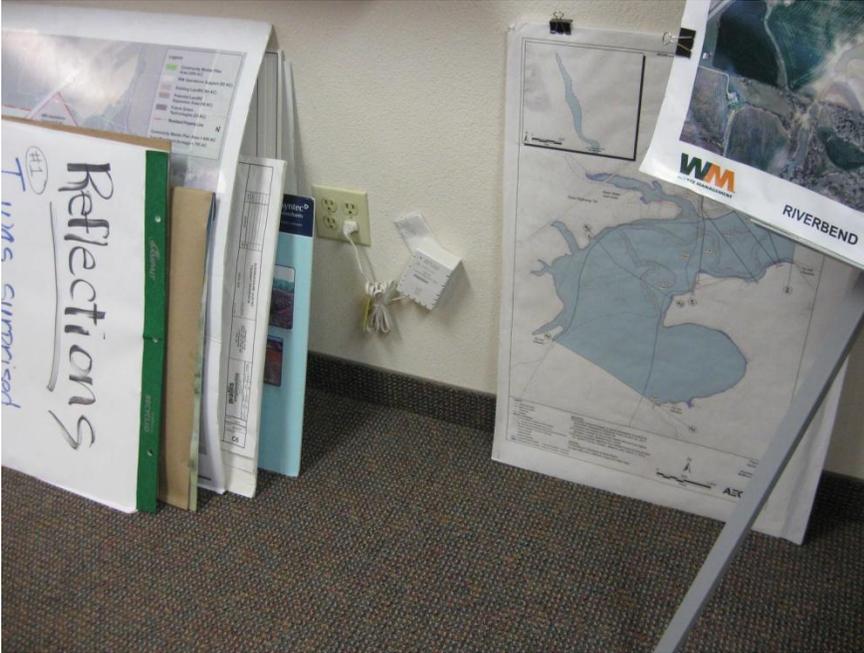
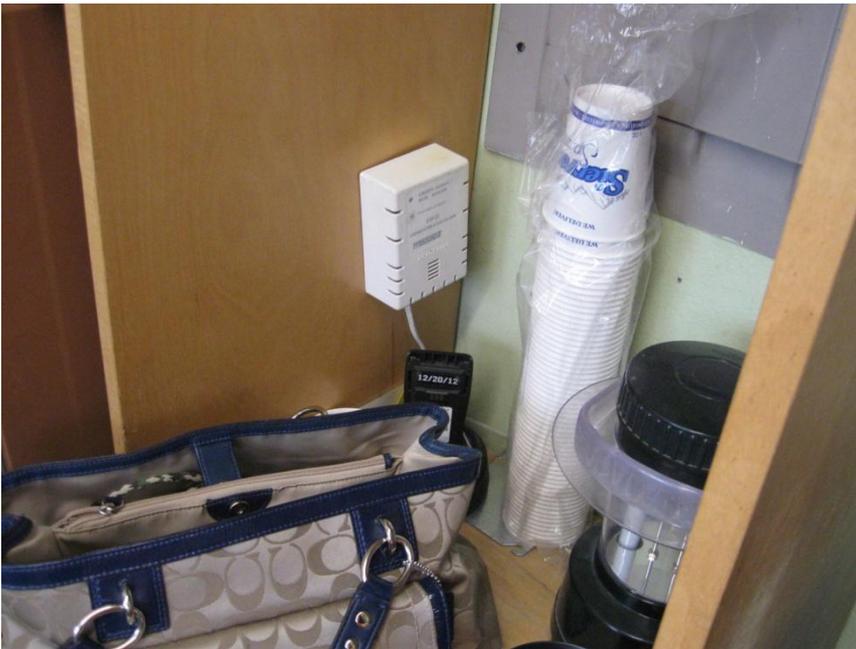
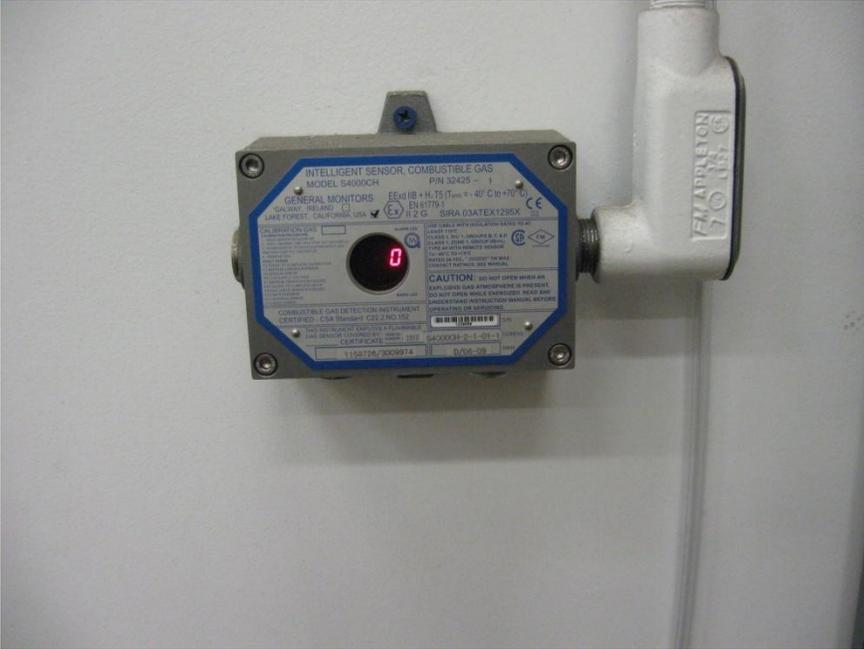
3. Landfill gas detection/alarm in conference room in main office.

4. Landfill gas detection/alarm in scale house.

5. Landfill gas detection/alarm in engine building.

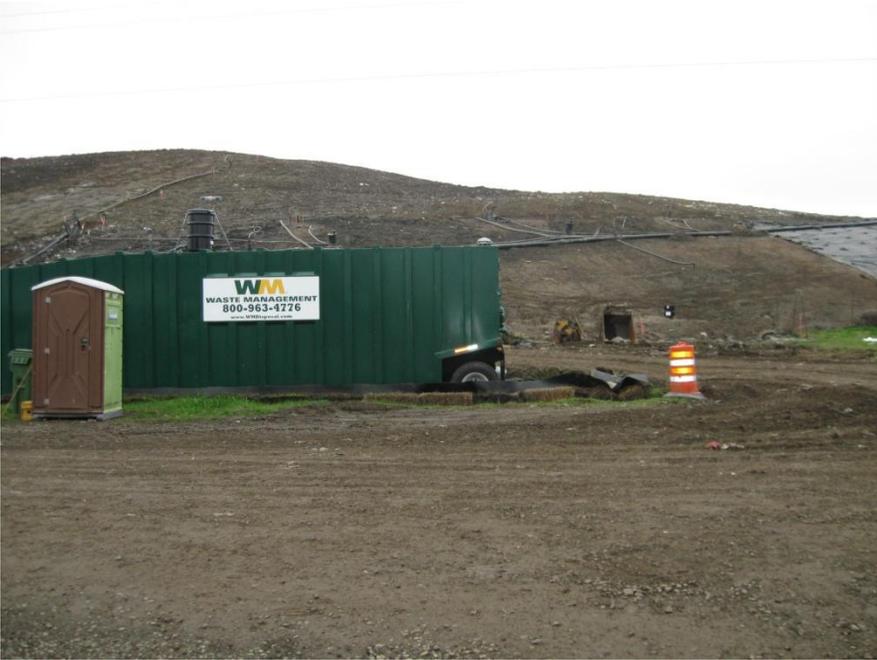
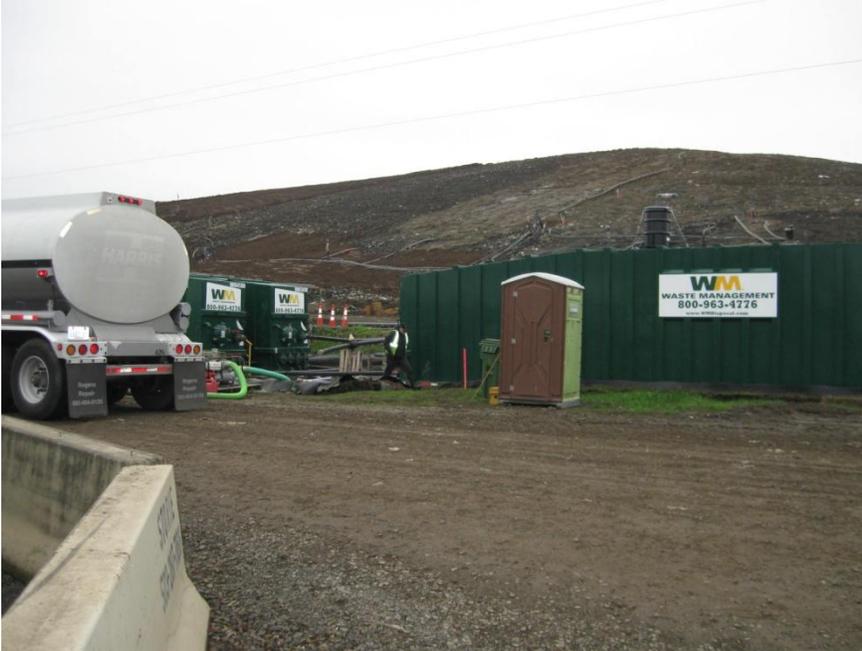
6. View of north slope, following completion of waste relocation for construction of north access road.

7. View of north slope, following completion of waste relocation for construction of north access road.
Foreground: the three 21,000-gallon tanks for landfill gas condensate and related leachate.

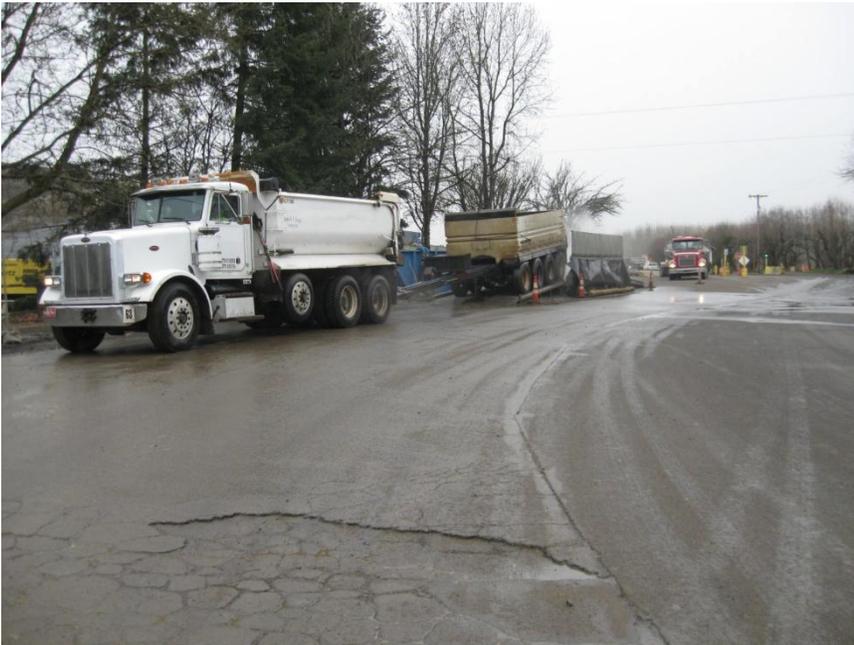
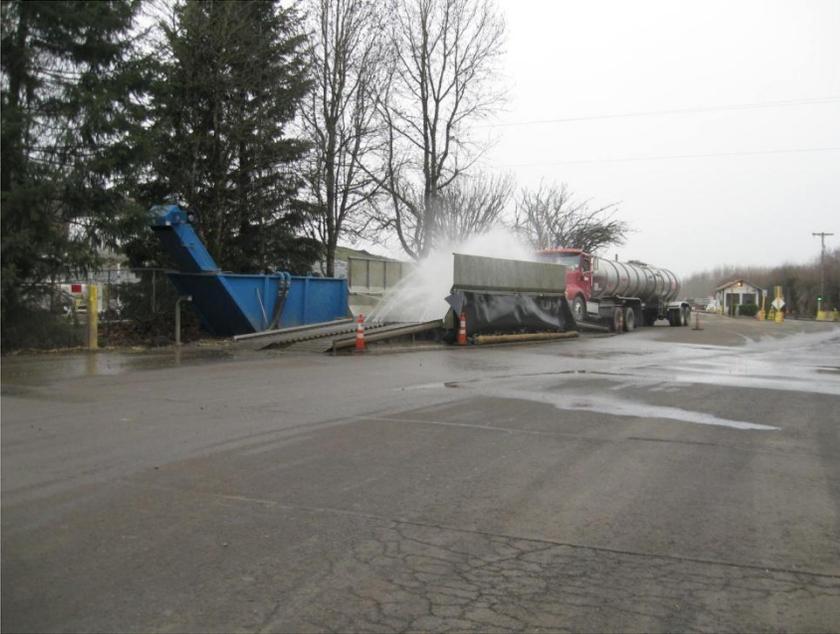
8. Wheel wash for removing mud from trucks and tires before trucks leave the site.

9. Wheel wash for removing mud from trucks and tires before trucks leave the site.

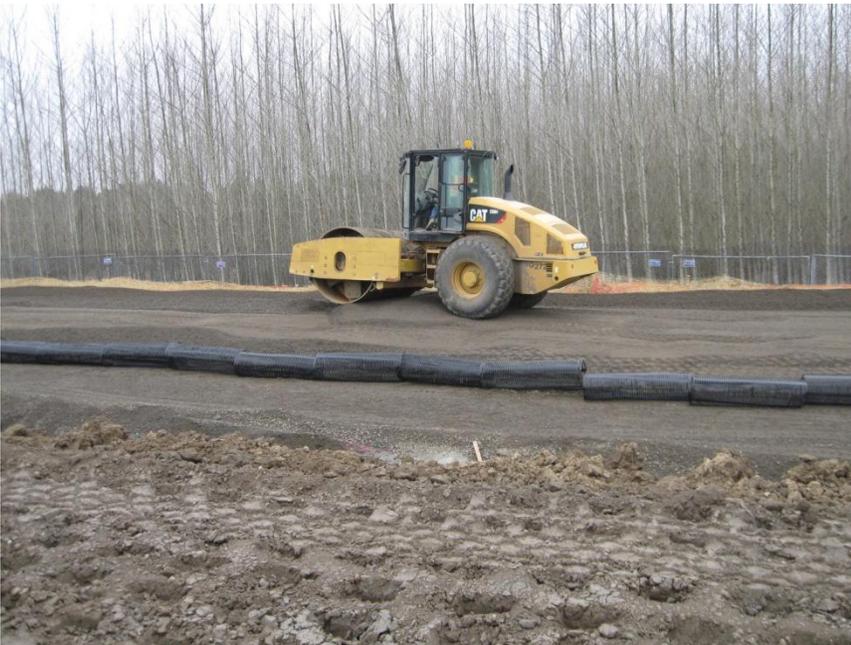
10. Smooth drum roller compacting granular soil for exterior portion of the mechanically stabilized earthen (MSE) berm. In midground: rolls of uniaxial geogrid used to reinforce this soil.

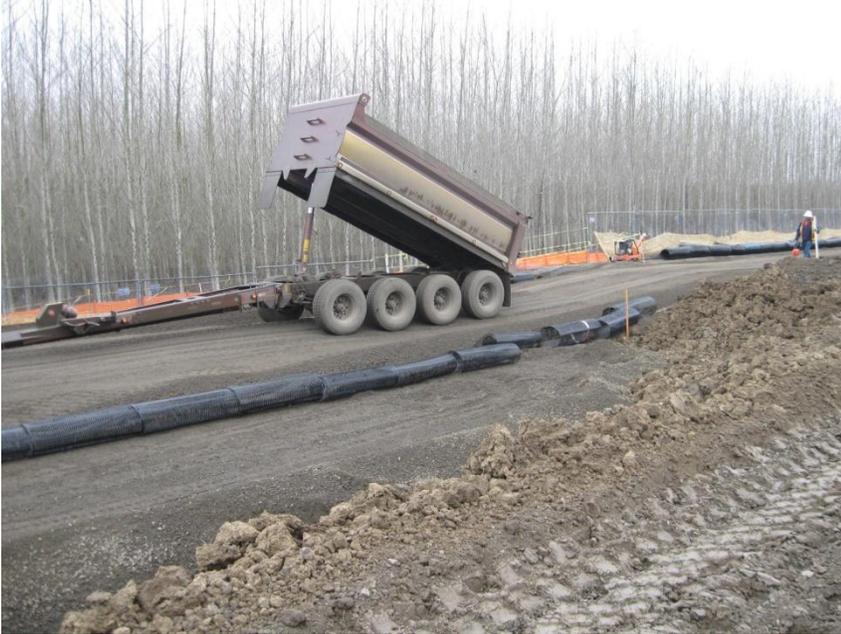
11. Unloading granular soil for reinforced fill zone of MSE berm.

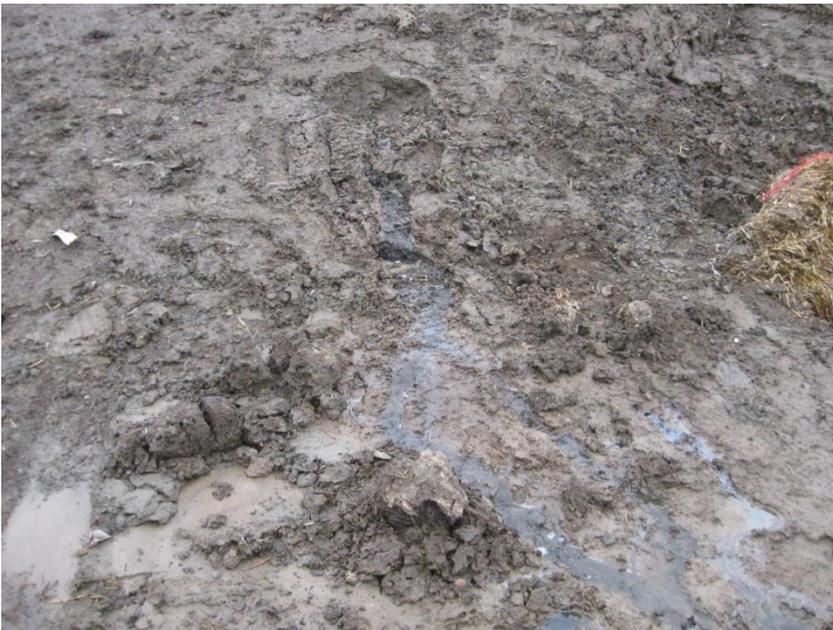
Leachate seep. Leachate was observed trickling through stormwater diversion berm on north side of landfill. Some of this leachate crossed the perimeter road along the northern edge of the landfill and flowed down to the grassy area north of the landfill.

Leachate weeping through stormwater diversion berm near northern edge of landfill.

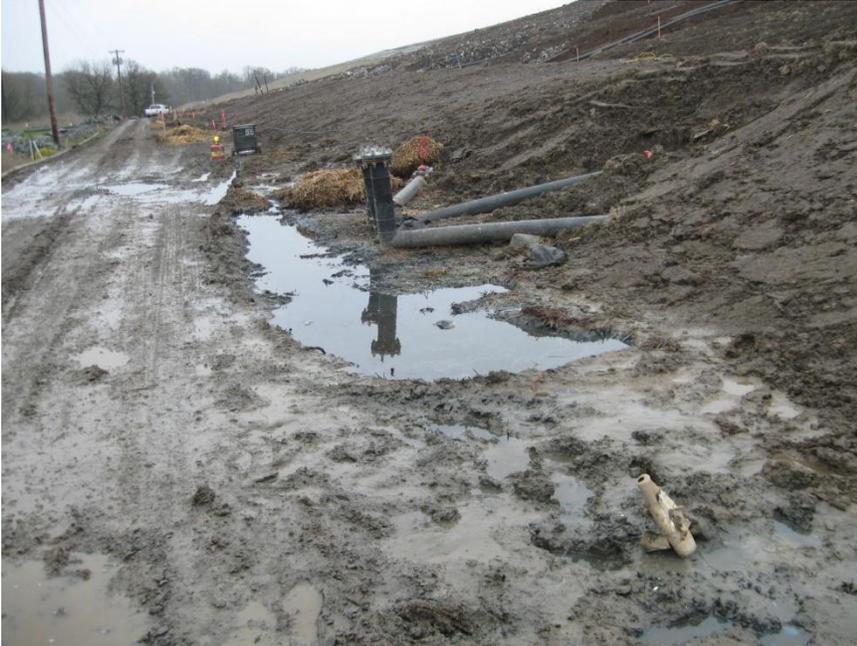
Ponded water, containing leachate, along northern road around landfill (looking east). In midground, this liquid is running across the road and into the grassy area to north of the landfill.

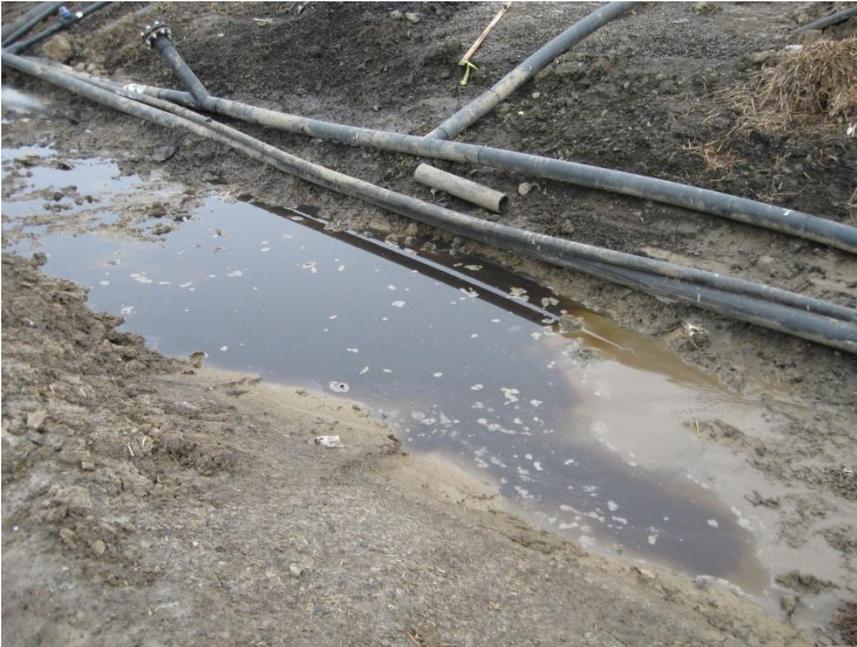
Leachate ponding on interior side of stormwater swale.

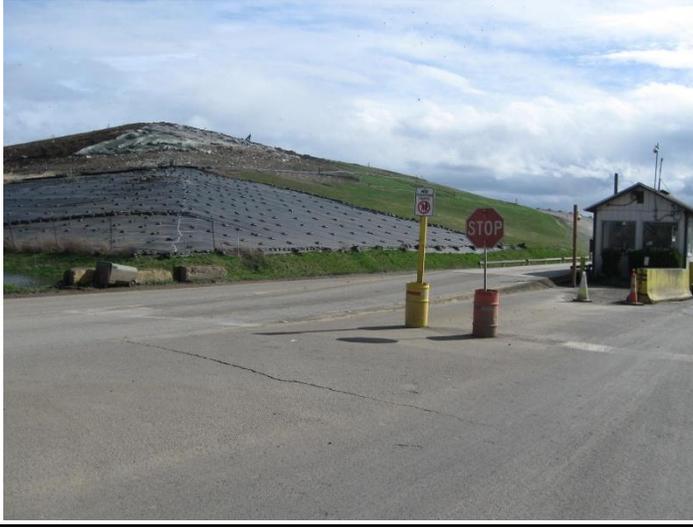
Photo shows state of grass cover on NW side of landfill, as well as cleanliness of road near scalehouse. Landfill roads near exit are generally free of mud. However, mud and stones remain on the center strip of Hwy 18 near landfill entrance. Contractor had been discussing with ODOT how to obtain permission to clean road. ODOT has recently said they intend to do it themselves.

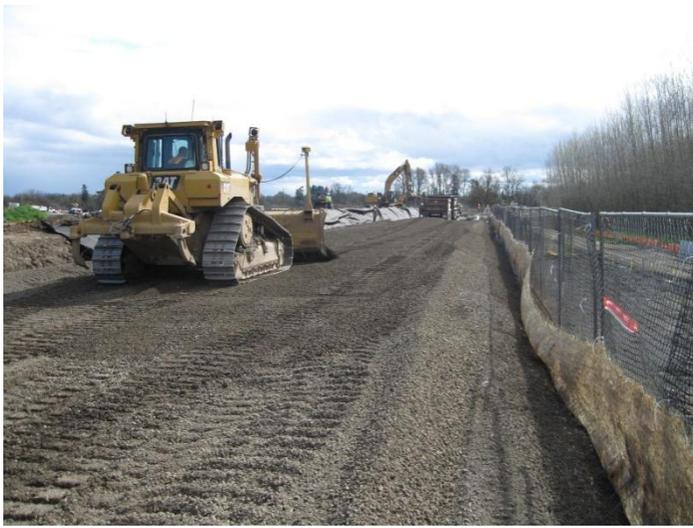
Spreading and compacting granular soil in the outer portion of the mechanically stabilized earthen (MSE) berm. This portion of the berm is the “reinforced fill zone”. It is reinforced by layers of uniaxial geogrid placed every 18 vertical inches.

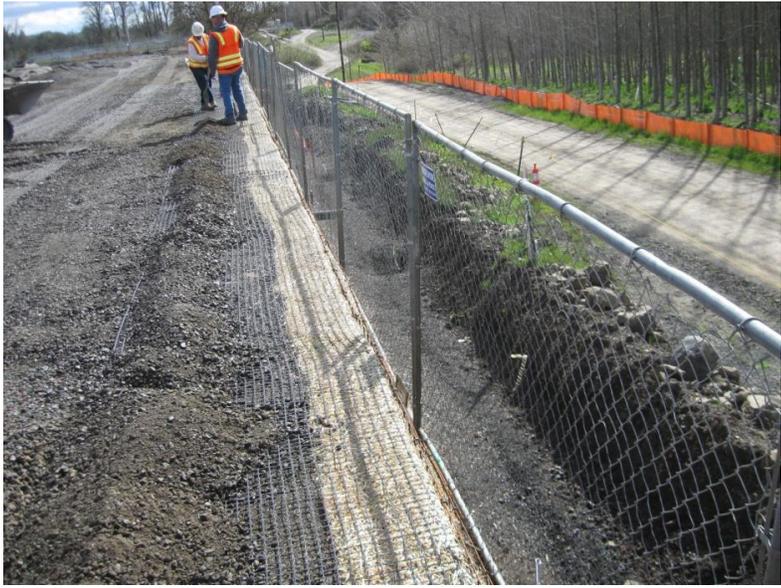
Outer face of MSE berm. Berm is 7 lifts high at this location. Each lift is 18 inches, so berm is approx 10 feet above surrounding ground elevation.

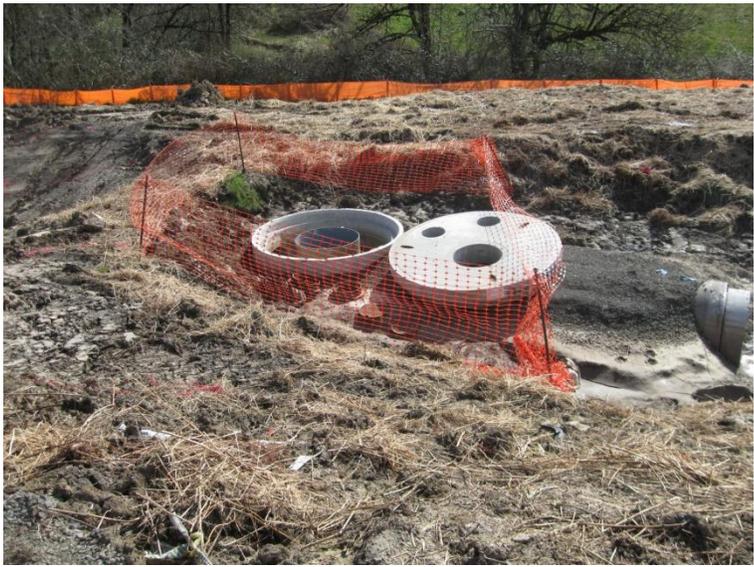
Inlet structure at uphill end of the stormwater drainage pond at SW corner of landfill. This pond was recently cleaned out as part of the MSE berm construction.

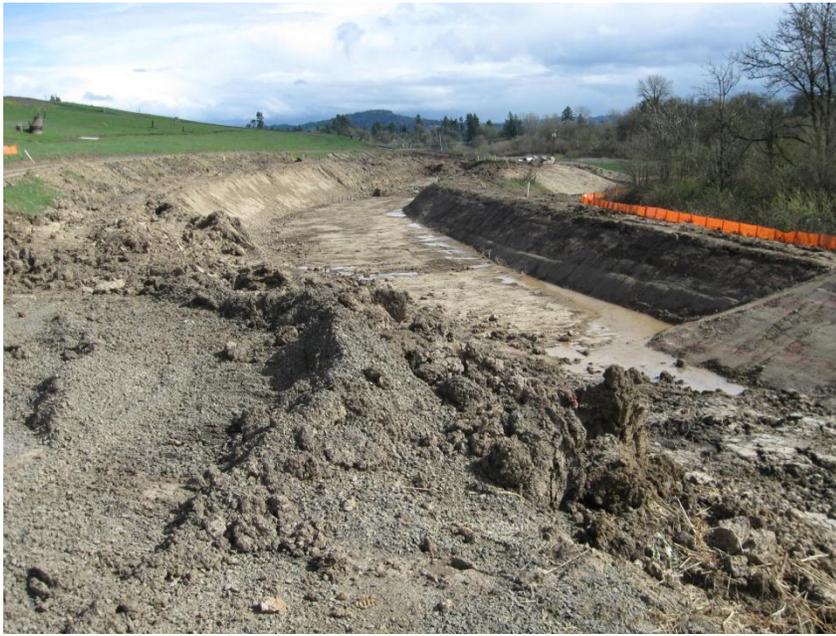
View of stormwater pond near SW corner of landfill, from the uphill (west) end, looking east.

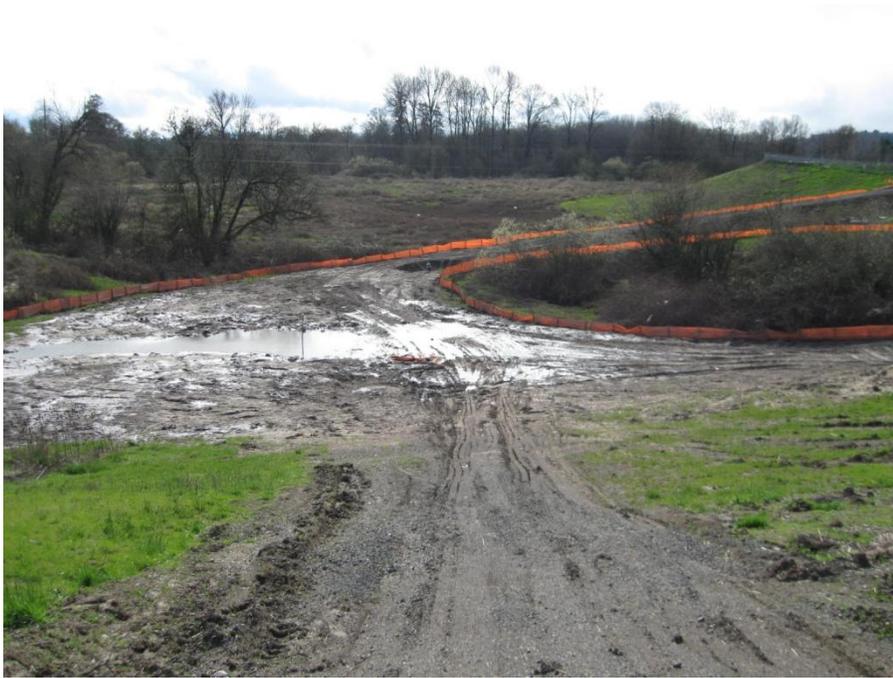
View of the cleanout pipe for the leachate line connecting sump 4/5 to the leachate pond. (Cleanout pipe is just left of where the orange construction fence takes a sharp bend.) The berm of the leachate pond is in the right side of the photo.

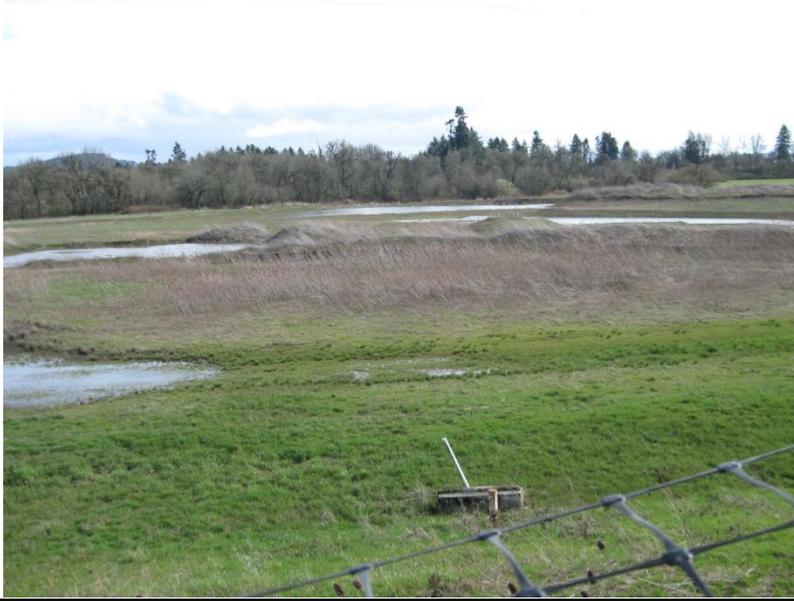
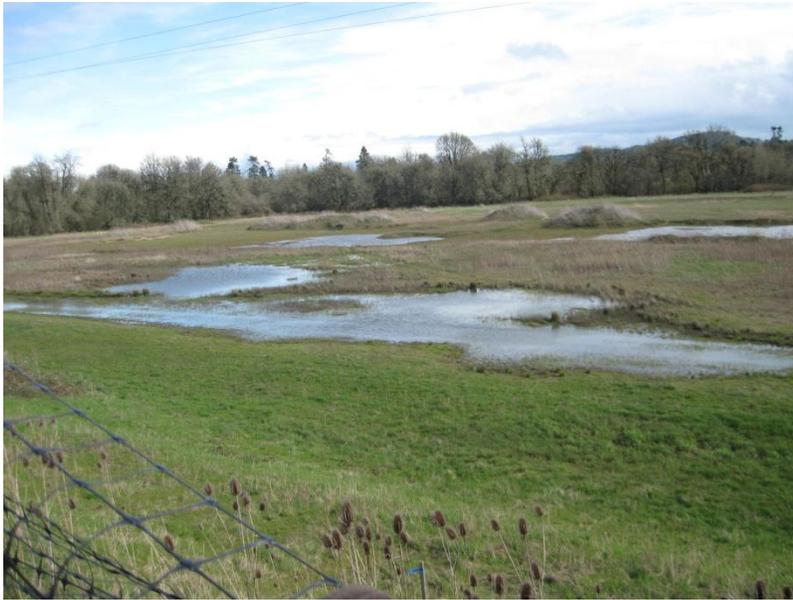
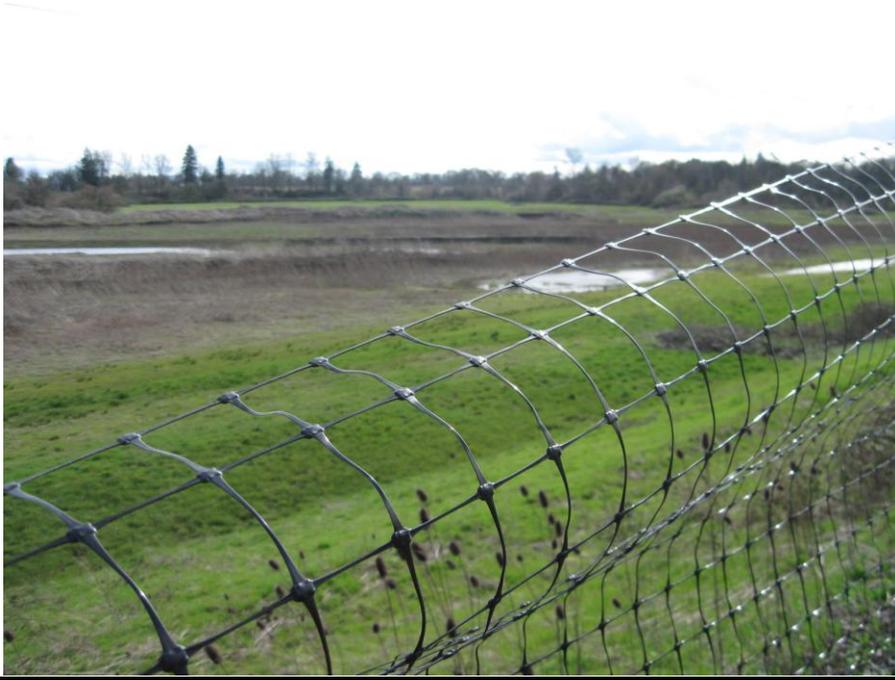
FOLLOWING THREE PHOTOS: Views of the soil borrow areas south of the landfill. This area has not been disturbed for at least two years. Soil removal from this area is only allowed during the summer months.

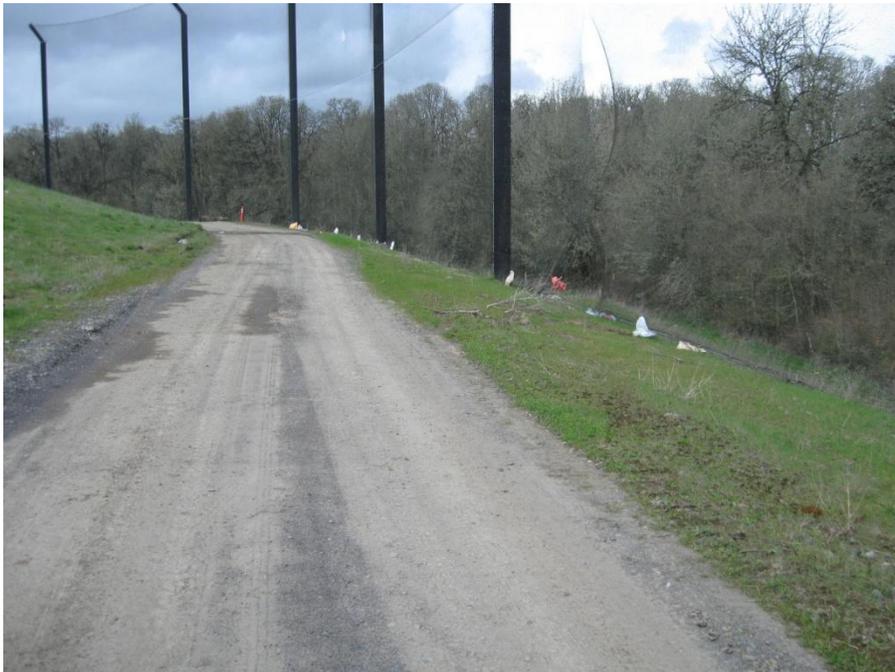
Tears in tall litter fence on east side of landfill. Some plastic bags have escaped from the landfill.

12.	Waste Unloading. Signs, fences, barriers clearly define waste unloading areas?	x			
Notes:					
13.	Litter. Litter controlled and picked up?		x		
Notes: I observed approximately 50 to 100 bags on the north and east sides of the landfill, blowing to the northeast. The tall litter fence placed there had several very large holes, and some of the bags were getting through the holes and leaving the landfill. Tim Watson mentioned that these slopes were free of litter just a few hours before, and were the result of the wind gusts that had started in the afternoon. Tim also said he was working on getting bids for repair of the litter fence. Following my inspection, I contacted the landfill by email and requested details of schedule for repair of the fence and improved litter control efforts.

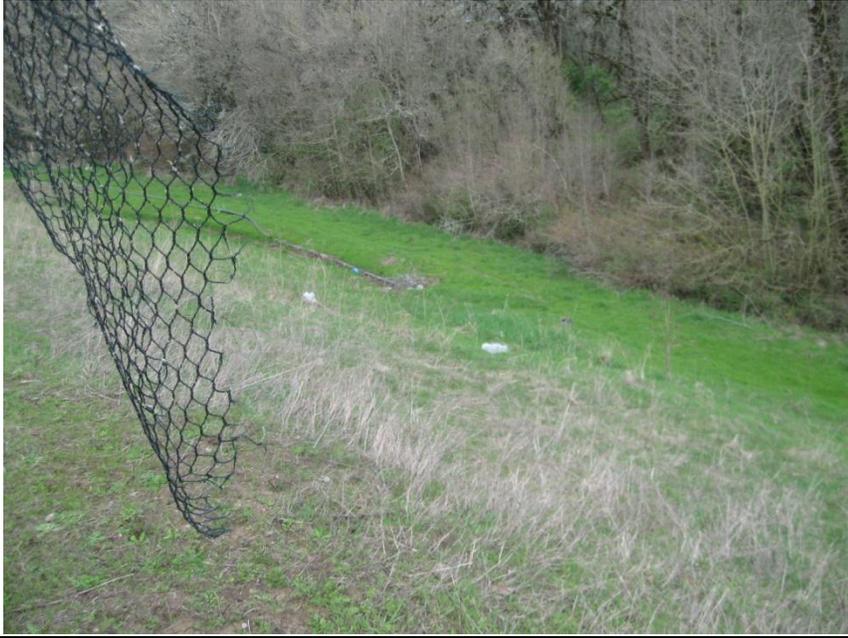
Plastic bags on east slope of landfill.

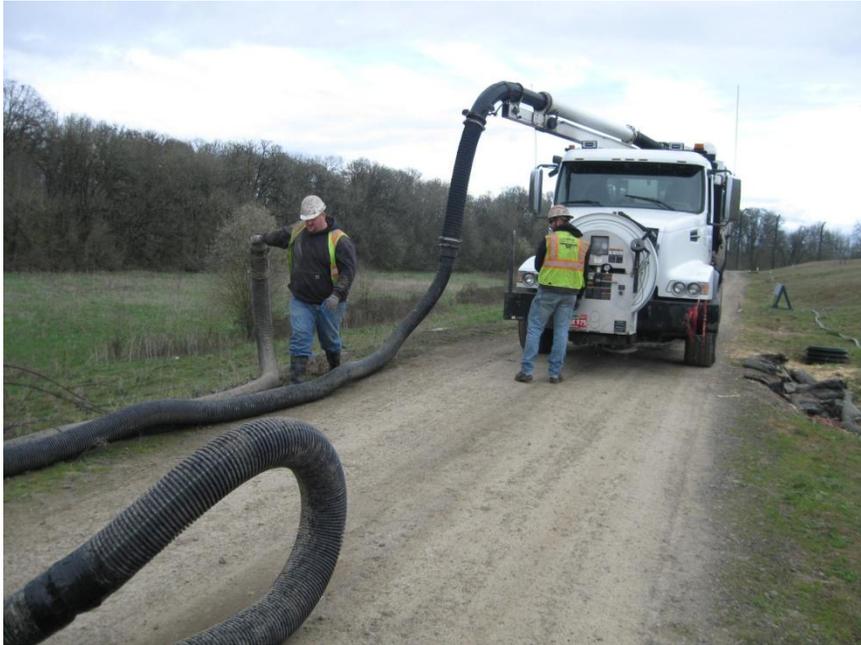
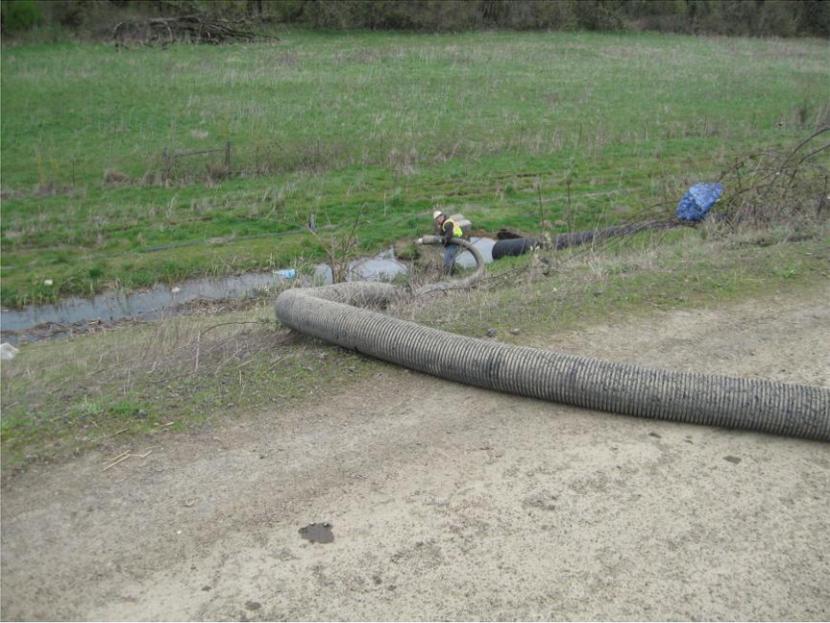
NEXT TWO PHOTOS: Pumping stormwater from swale at base of landfill. This is done to prevent weakening of soil at the base of the landfill berm.
