State of Oregon  
Department of  
Environmental  
Quality

DEQ Solid Waste Program

**LANDFILL INSPECTION REPORT**

<b>FACILITY:</b>	Riverbend Landfill		
<b>COUNTY:</b>	Yamhill	<b>PERMIT NO:</b>	345
<b>INSPECTOR(S):</b>	Bob Schwarz	<b>INSPECTION DATE:</b>	Apr. 8, 2014
	<b>Start time:</b>	8:30 am	<b>End time:</b> 11:30 am
<b>Site Weather Conditions:</b> Cloudy, mid 50s F			
<b>Facility Representatives:</b>	Tim Watson, Jeff O'Leary		
<b>Inspection type:</b>	Announced landfill inspection		
<b>Facility Type:</b>	MSW Landfill		
<b>INSPECTION SUMMARY/KEY ITEMS:</b>			
<p><b>Litter. During March 19 inspection,</b> did observed plastic bags blowing off the landfill on the NE side. The litter fence on this side had large holes and bags were escaping from the landfill. As shown in photos below, the fence has been repaired. I did not see blowing litter during this inspection, though some plastic was captured by the litter fence.</p> <p><b>Erosion and sediment controls.</b> Road sweeping contractor has received approval from ODOT. Road is largely free of mud and rocks. However, it is stained brown, despite cleaning efforts.</p> <p><b>MSE berm.</b> Work continues. Reinforced fill zone soil (gra

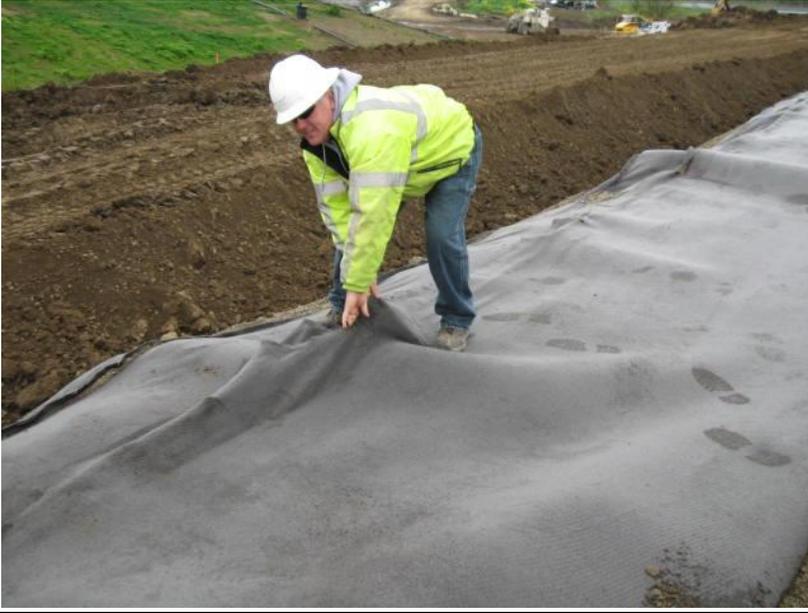
Photo shows the geosynthetic “chimney drain”. This is a geocomposite (drainage net sandwiched between two layers of geotextile) that runs vertically along the length of the berm, and separates the clay soil on the interior of the berm from the granular, reinforced soil on the exterior.

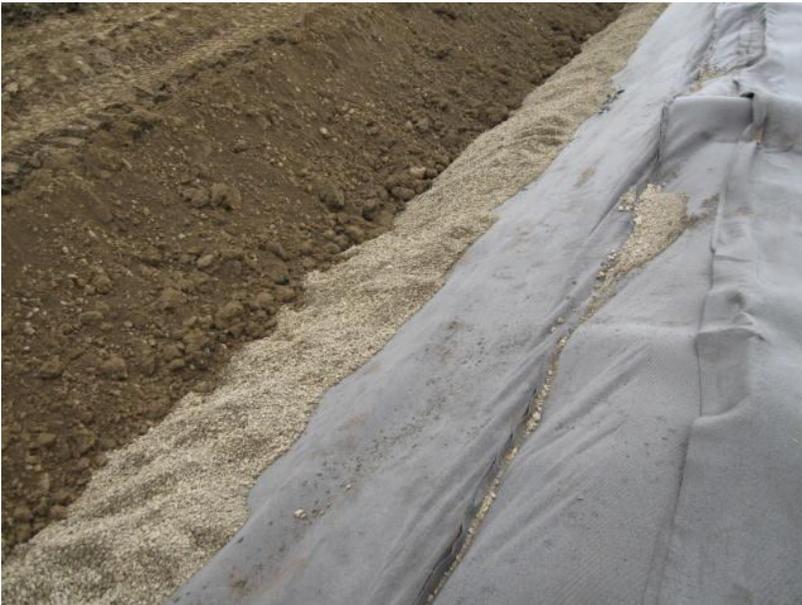
The contractor placed gravel along the outside of the chimney drain to protect it from damage during installation.

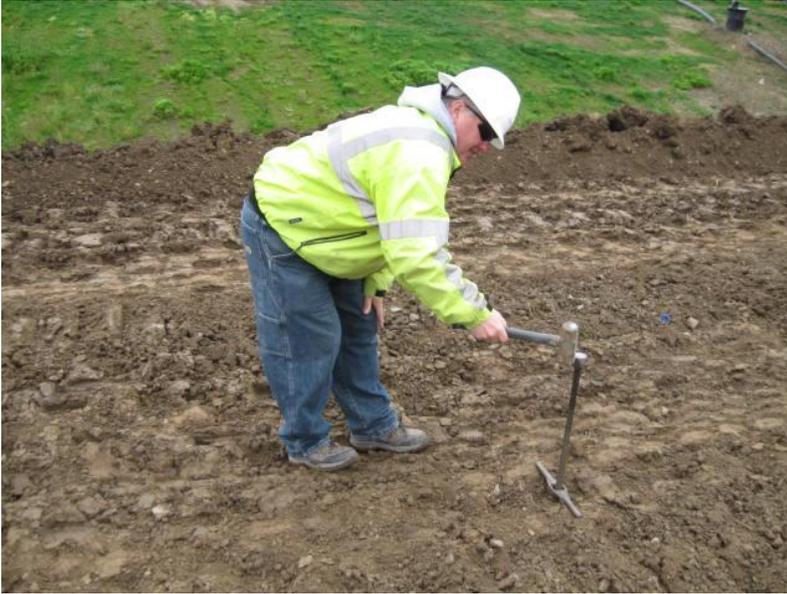
The clay for the berm interior is treated with cement to increase strength. Construction inspector hammers rod into treated clay as a qualitative test of the clay's strength.

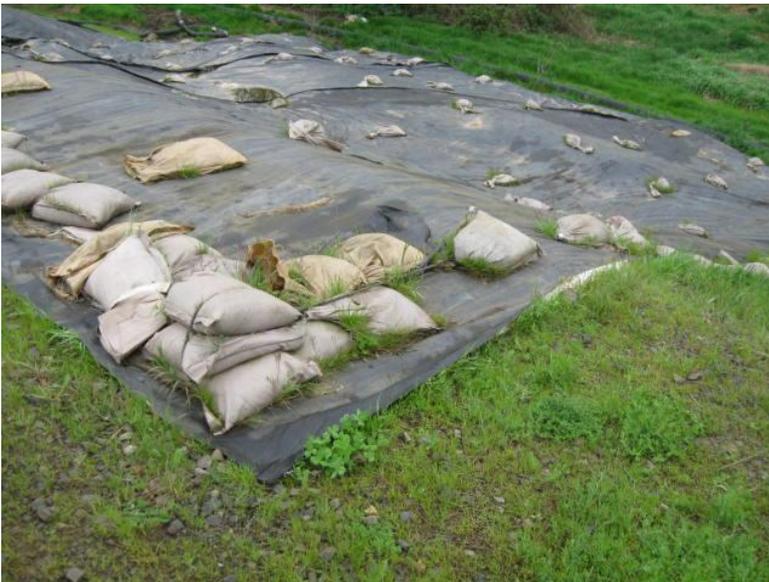
Topsoil has been observed sloughing off the perimeter berm on the north side of the landfill. A tarp was placed over a portion of this area to reduce the amount of rain getting into the soil. Waste Management's consultant, GeoSyntec, is evaluating how to correct this problem.

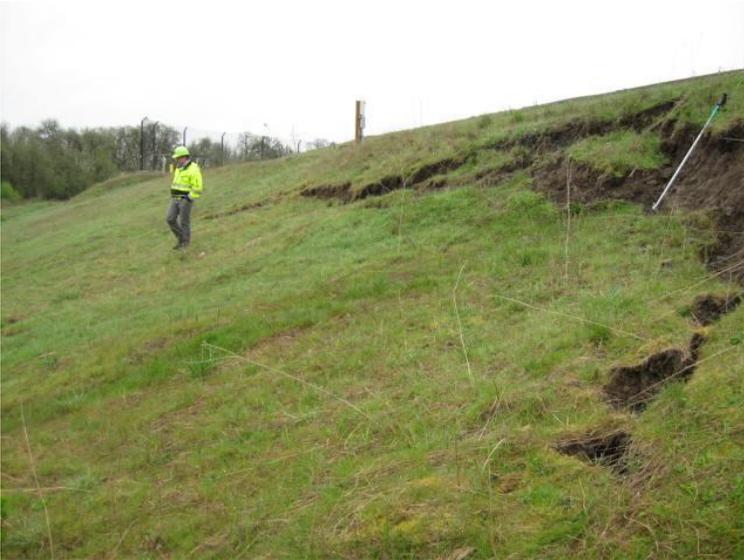
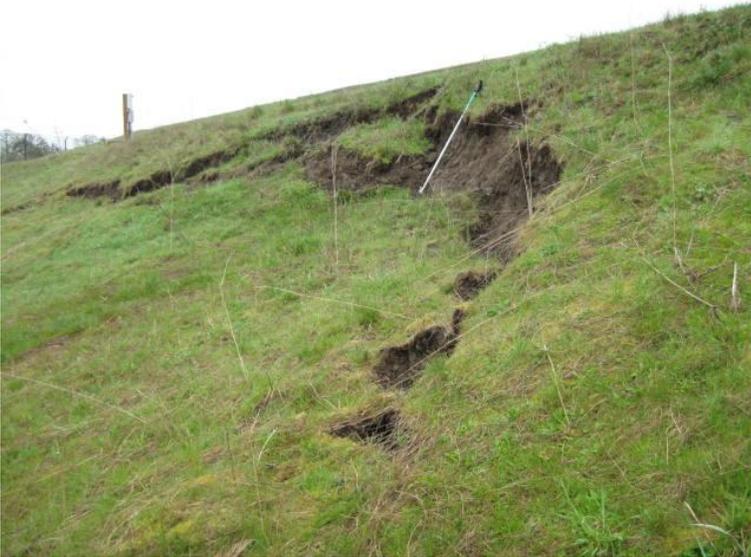
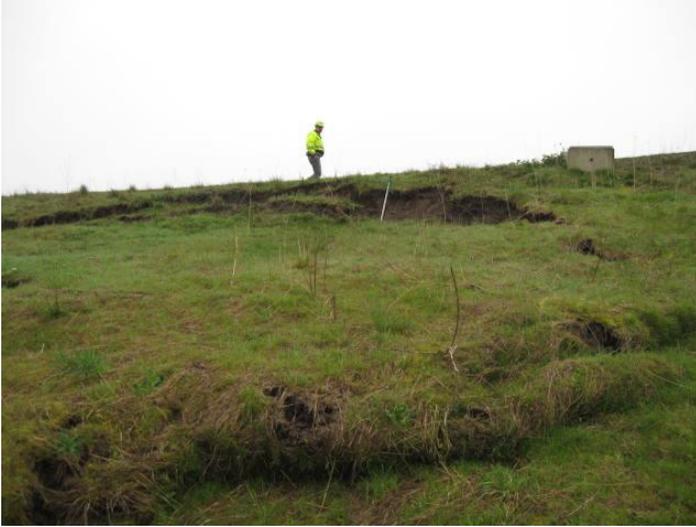
NEXT THREE PHOTOS: Other areas on north berm with soil sloughing.

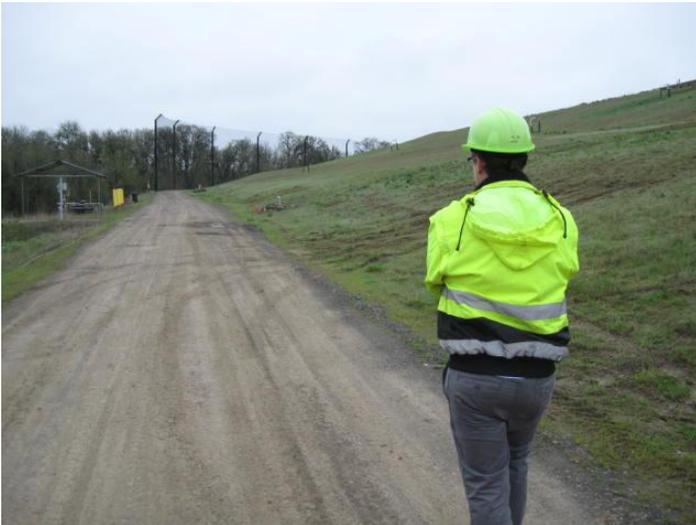
View of NE side of landfill. Blowing litter was observed during the previous inspection on March 19. Very little litter was observed today.

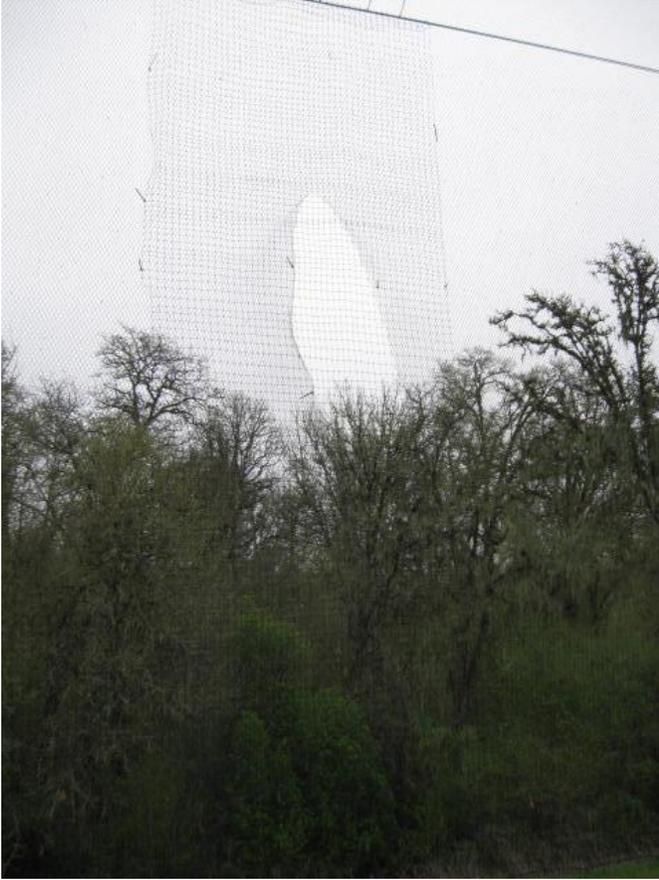
The litter fence installed on the NE side of the landfill. During the March 19 inspection, large holes were found in the fence. These have been repaired. Some litter was observed at the bottom of the fence.

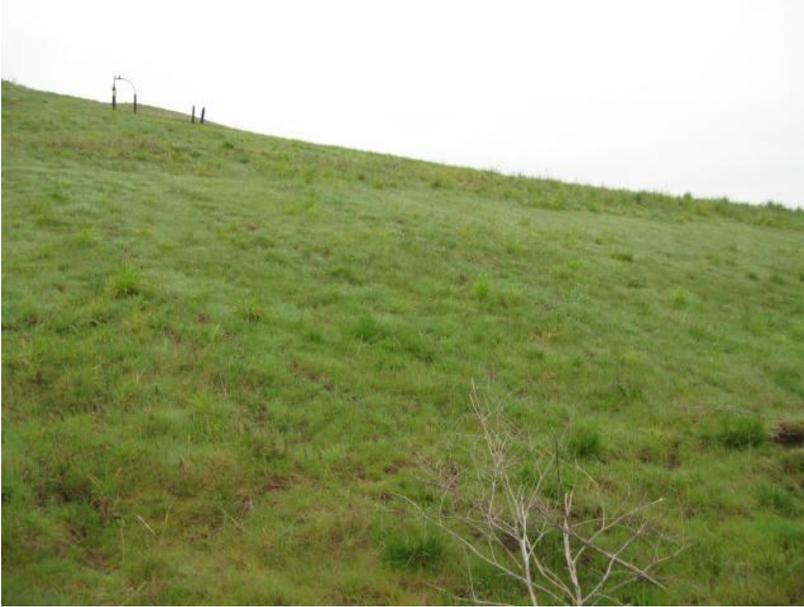
View of landfill's NE slope. As noted above, blowing litter was observed during the March 19 inspection. Much less blowing litter was seen today.

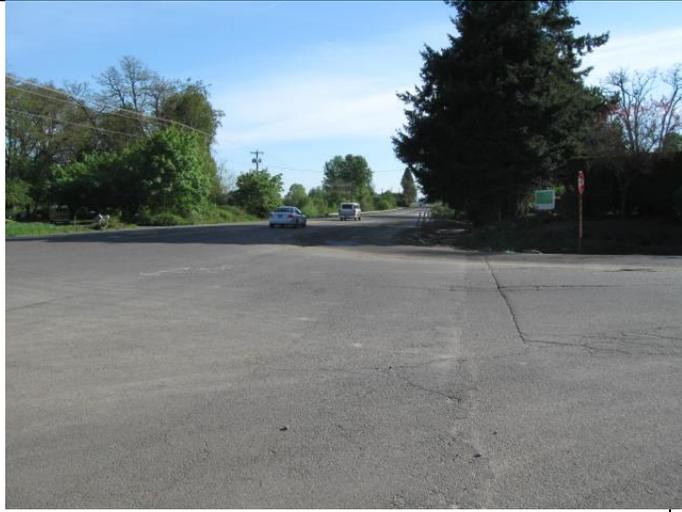
Road cleanliness. At 8:30 am, dirt on road was causing vehicles to raise dust clouds. Sweep Rite comes to the site at approximately 9 am, 1 pm, 4 pm and late at night. Road was inspected again at 9:45 am after the first sweeping of the day. Conditions were greatly improved.

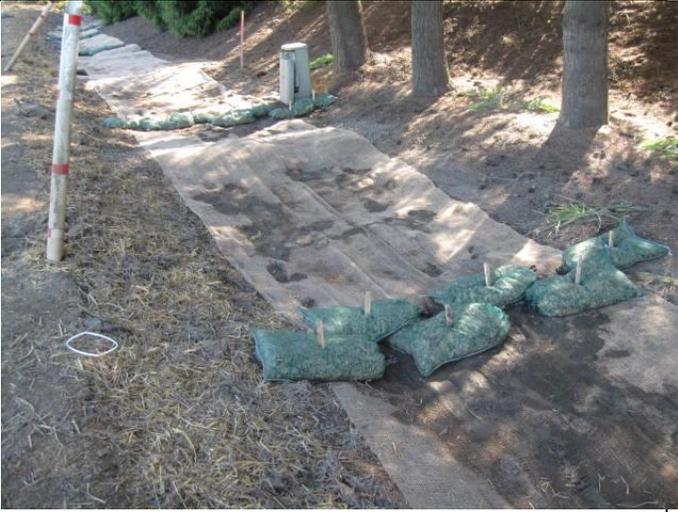
Erosion control features in swale along landfill side of Hwy 18. Mulch bags are staked into ground. Jute mesh lines the swale. Mulch bags are above, gravel check dams are beneath.

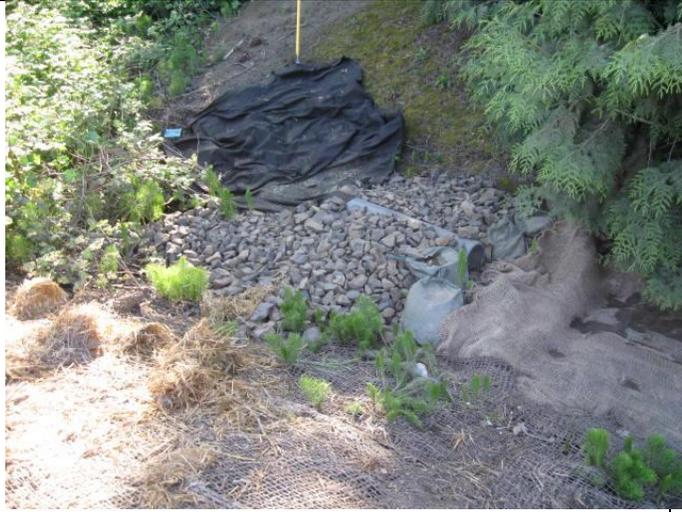
Downstream end of jute mesh, where swale leads to creek. Outlet is filled with gravel and a steel pipe, the end of which is covered by geotextile to filter sediment out of discharging water.

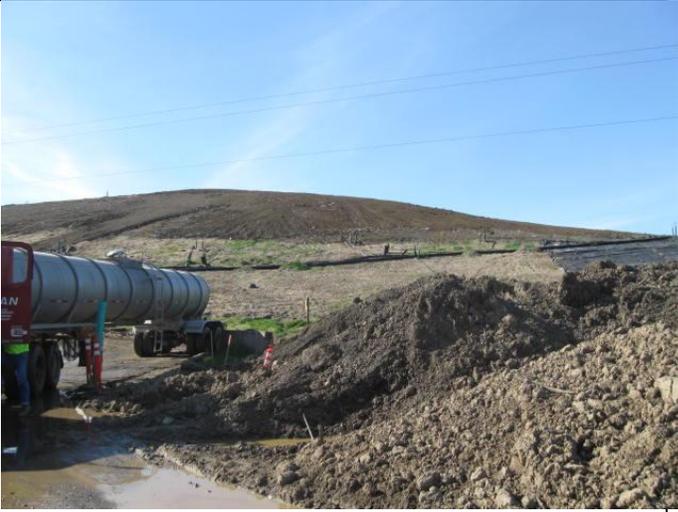
View of NW slope of the landfill. WM plans to add additional soil on this area to complete the 18" intermediate cover

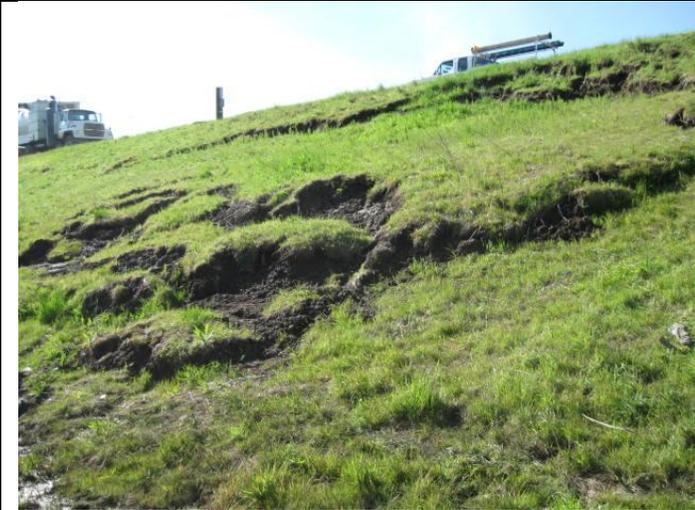
Soil sloughing on north slope. Geosyntec will submit plans by June to repair this area. The repair work will be done in late summer, when conditions are driest.

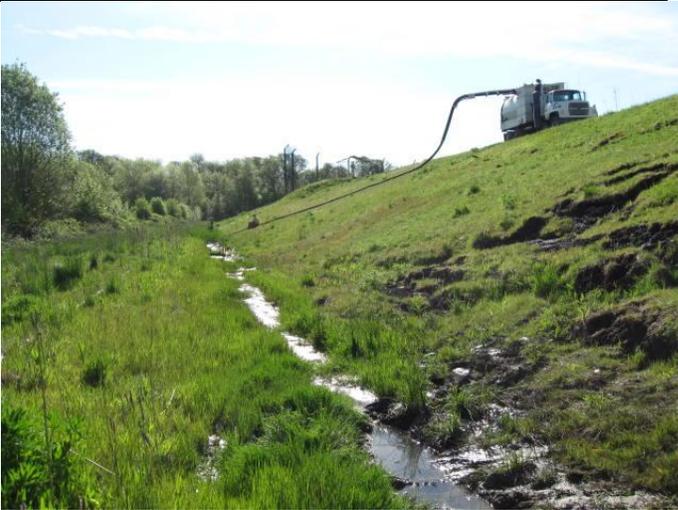
Soil sloughing area. Also shown is vac truck removing stormwater from base of slope, to reduce potential for further sloughing.

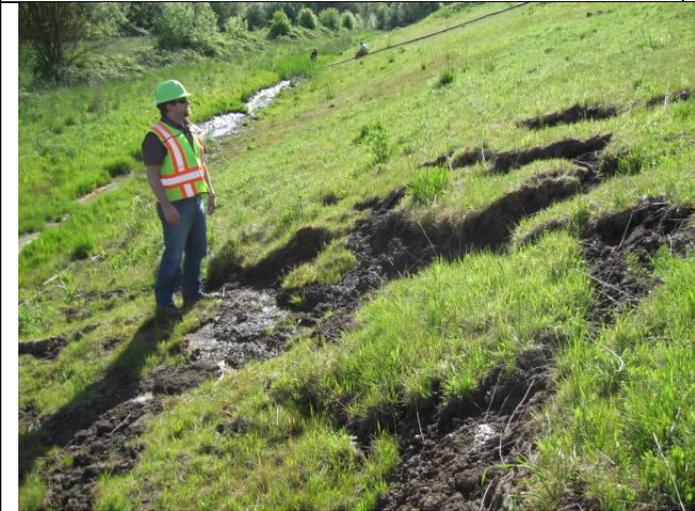
Close up view of area with sloughing soil.

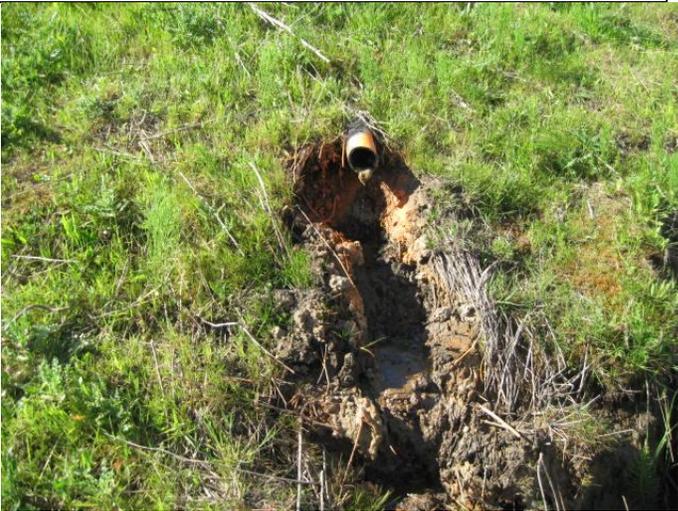
Drain pipe installed during cell construction. These are contributing to sloughing problem, and will be evaluated by Geosyntec.

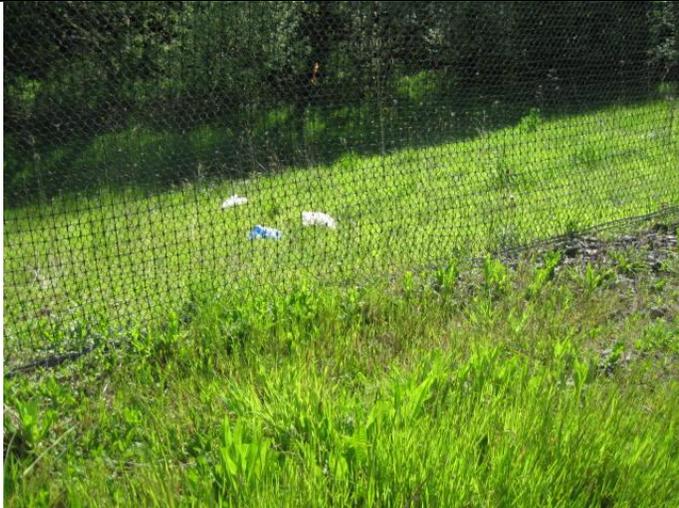
Tall litter fence on NE side of landfill. Some plastic litter was observed outside the fence. Holes in fence noted during April 8 inspection have been repaired.

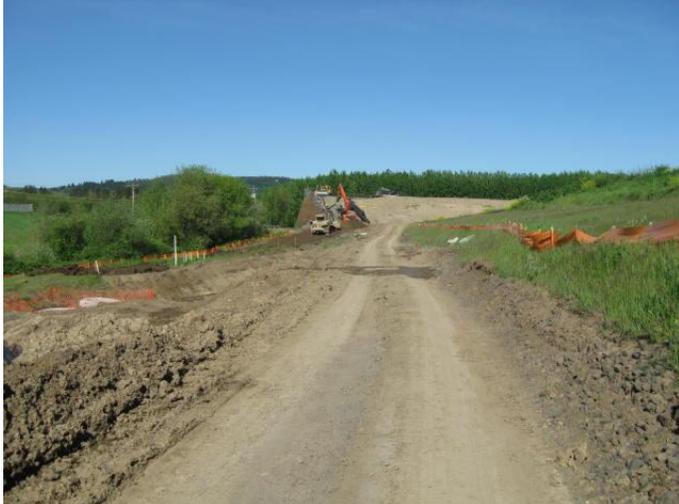
View of MSE berm, looking west from south side of landfill.

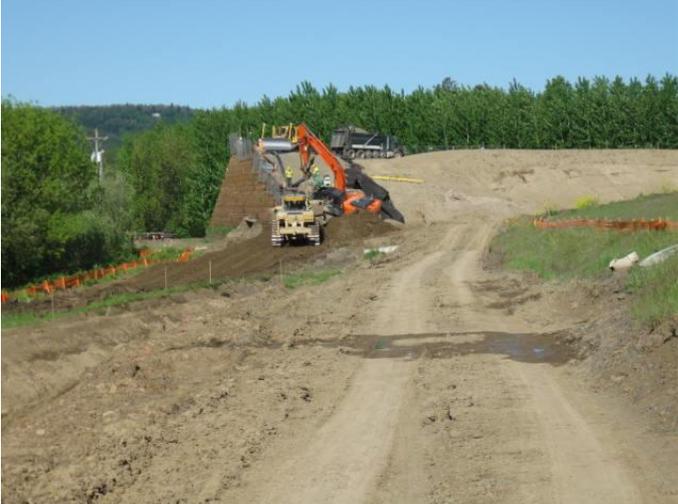
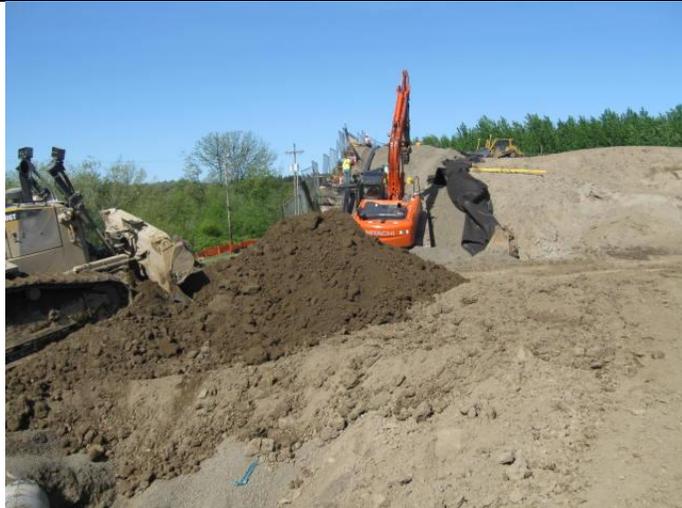
Building the south end of the MSE berm.

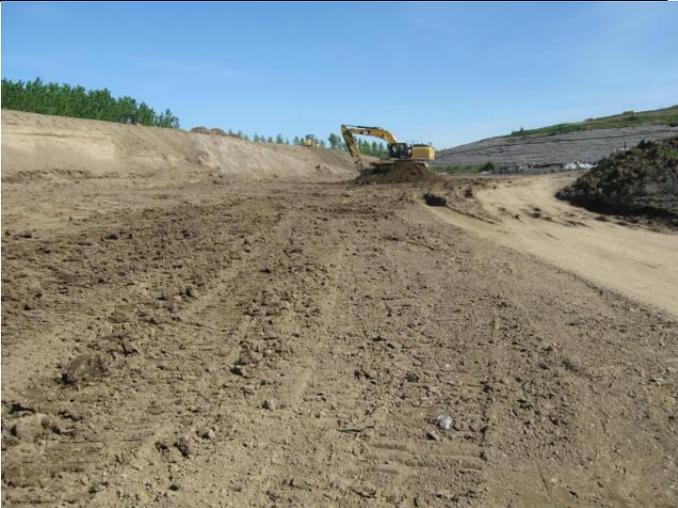
Clay stockpile for MSE berm. Clay is blended with cement at 5 percent to dry it and increase its strength. In the lower, wider berm lifts, clay is placed and then blended with cement. In these upper berm lifts, which are narrower, the clay is blended with cement away from the berm and then the clay/cement mixture is hauled to the berm for compaction.

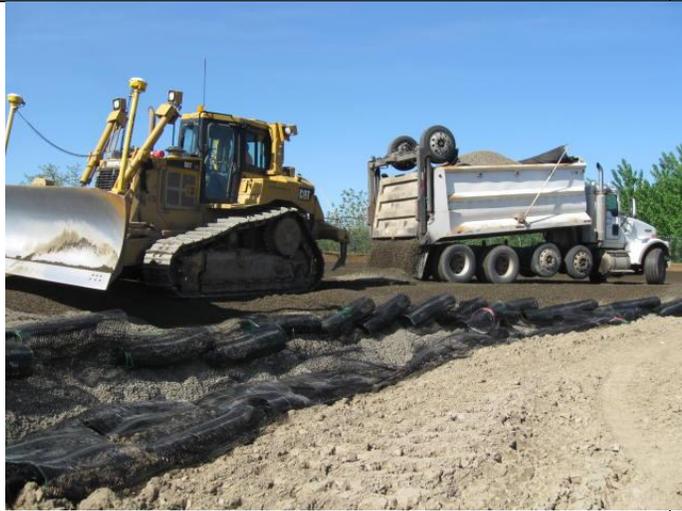
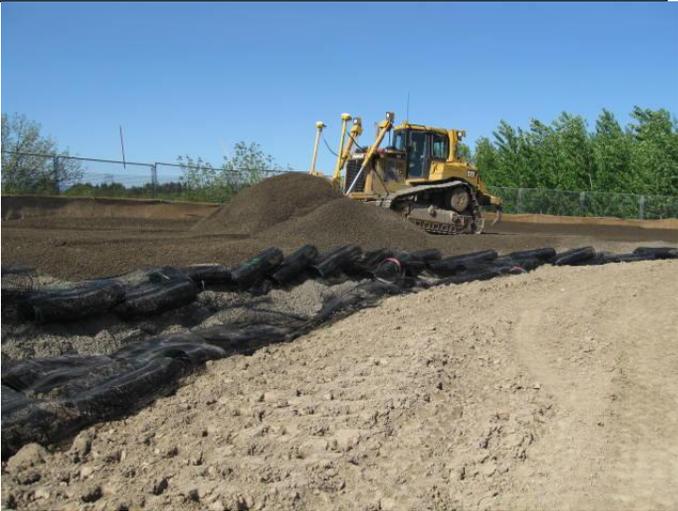
Placing and spreading granular soil in the reinforced fill zone (outer half of the MSE berm).

Placing and spreading granular soil in the reinforced fill zone.

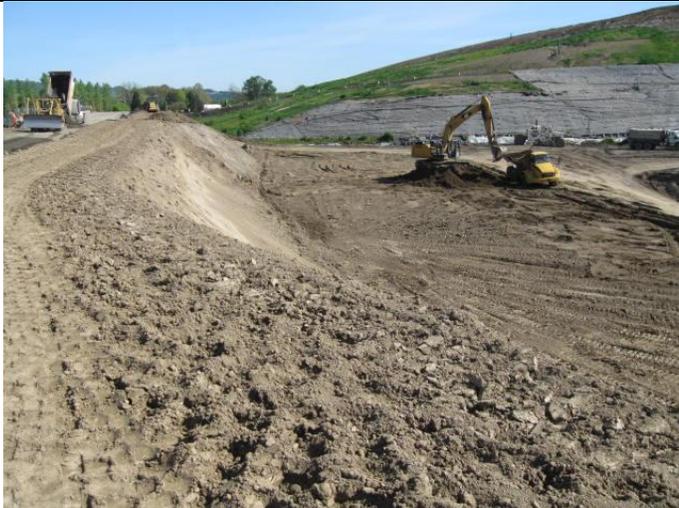
View of the MSE berm's inner, clay slope, from the top of the berm.

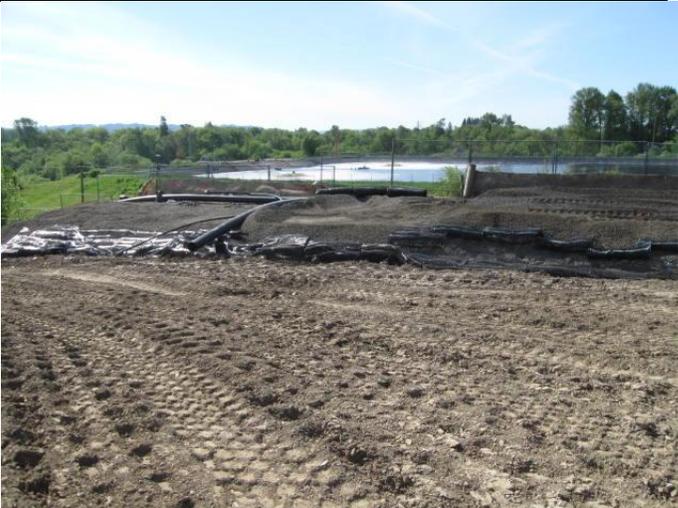
View of leachate storage pond. Liquid level is higher than usual due to heavy spring rains. Freeboard is approximately 8 feet (minimum allowable is 3 feet).

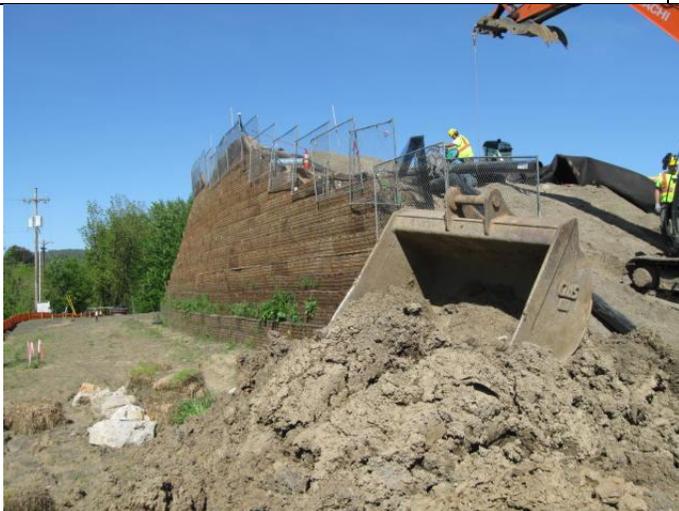
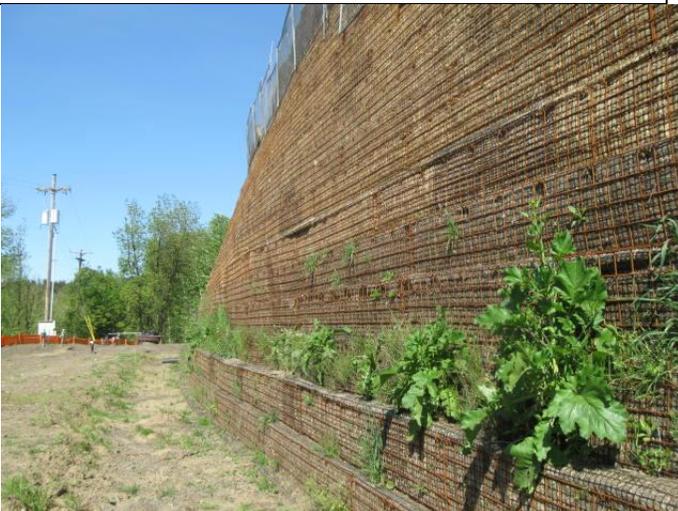
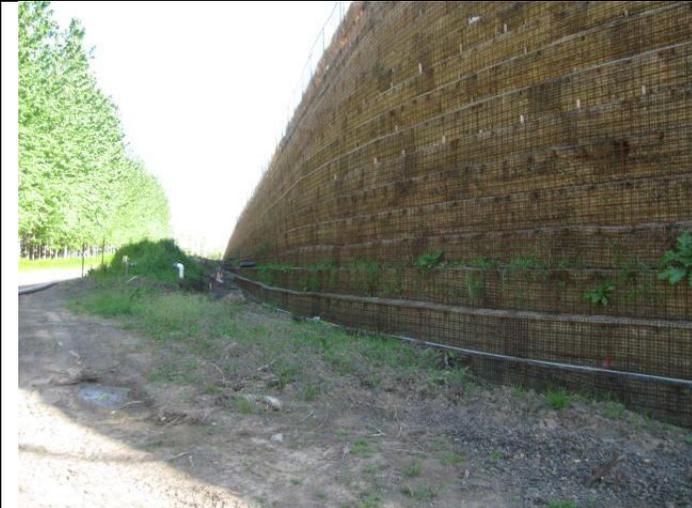
View of MSE berm exterior face. Welded wire cages are placed along the outside of each 18-inch lift to hold topsoil until vegetation is established. The exterior will be hydroseeded after the berm construction is complete.

MSE berm exterior face.

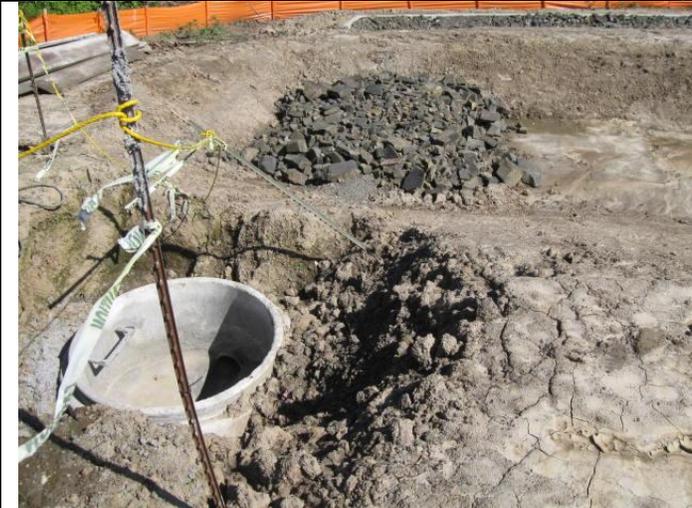
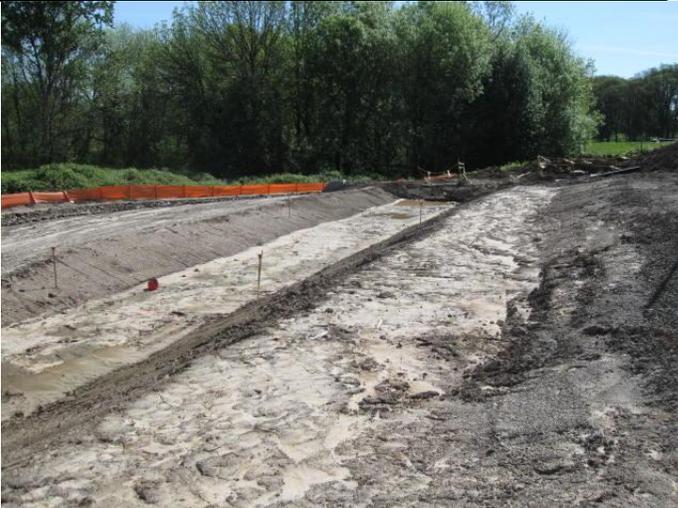
Stormwater retention basin for the front entrance area.
