## REQUEST FOR TRANSIT VEHICLE PRICE QUOTE (RFQ)

VENDOR (Business Name): SCHETKY NW SALES

Agency: Yamhill County Transit Area Date: 9/2//2021  
Contact Person: Cynthia Thompson Phone: 503-995-7965  
Email Address: [Thompsonc@co.yamhill.or.us](mailto:Thompsonc@co.yamhill.or.us)

Report Number: LTI-BT-R1617

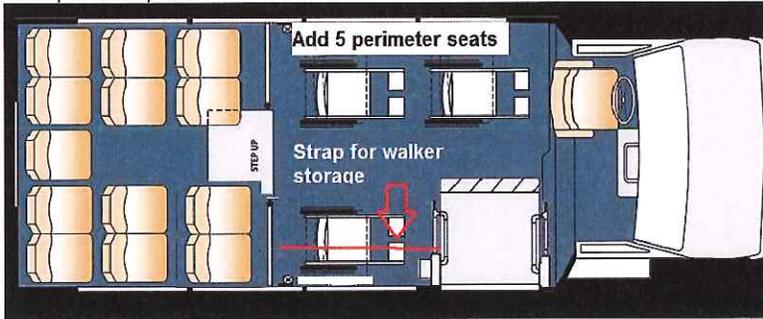
<p>Floor plan with front load wheelchair access and 3 wheelchair stations, seating for 18 using perimeter seats in wc area and ff in rear section of bus, walker / interior bike storage behind ramp. Red line indicates location of single strap to secure bikes/walkers that is easily accessed/hooked by driver. Strap should be approx 6" out from the wall. Check with Agency for correct location before installation.</p> <p>Sample floorplan</p>

<p>The diagram is a top-down view of a bus interior. It shows a driver's seat on the right side. Behind the driver's seat is a wheelchair station with a ramp. A red line indicates a strap for walker storage. There are five perimeter seats along the side walls. A 'STEP UP' label is near the wheelchair station. Text labels include 'Add 5 perimeter seats' and 'Strap for walker storage'.</p>	PROVIDED
Q-Straint (or equivalent) auto-tensioning wheelchair securements with TDSS Storage under folding seats or wall storage as appropriate – NO Bags. (2) wheelchair seat belt extenders.	PROVIDED-Q'STRAIT QRT 360 RETRACTABLE QUOTED WITH TDSS

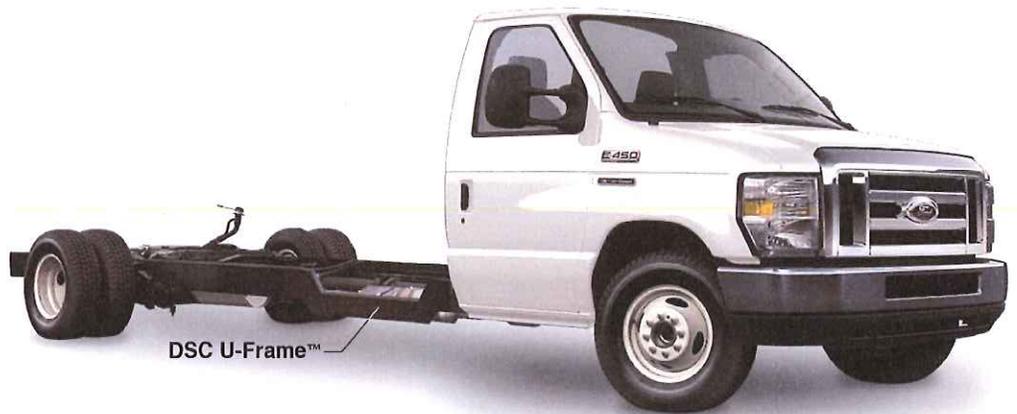
DSC U-Frame™

- ✓ **Intelli SYNC®** Air-Ride Suspension System.
- ✓ Rated for up to 500 full vehicle kneel cycles within a 24-hour period of continuous use, 365 days a year.
- ✓ DSC Intelli SYNC® 210 10CFM High Duty Cycle Compressor (DC or engine driven).
- ✓ No steps, 1:6 purpose-built accessibility.
- ✓ "Buy America" certified.
- ✓ Standard limited 3-year/36,000 mile warranty.
- ✓ Wide-Trac™ Air Ride Suspension System for enhanced vehicle lateral & longitudinal stability.

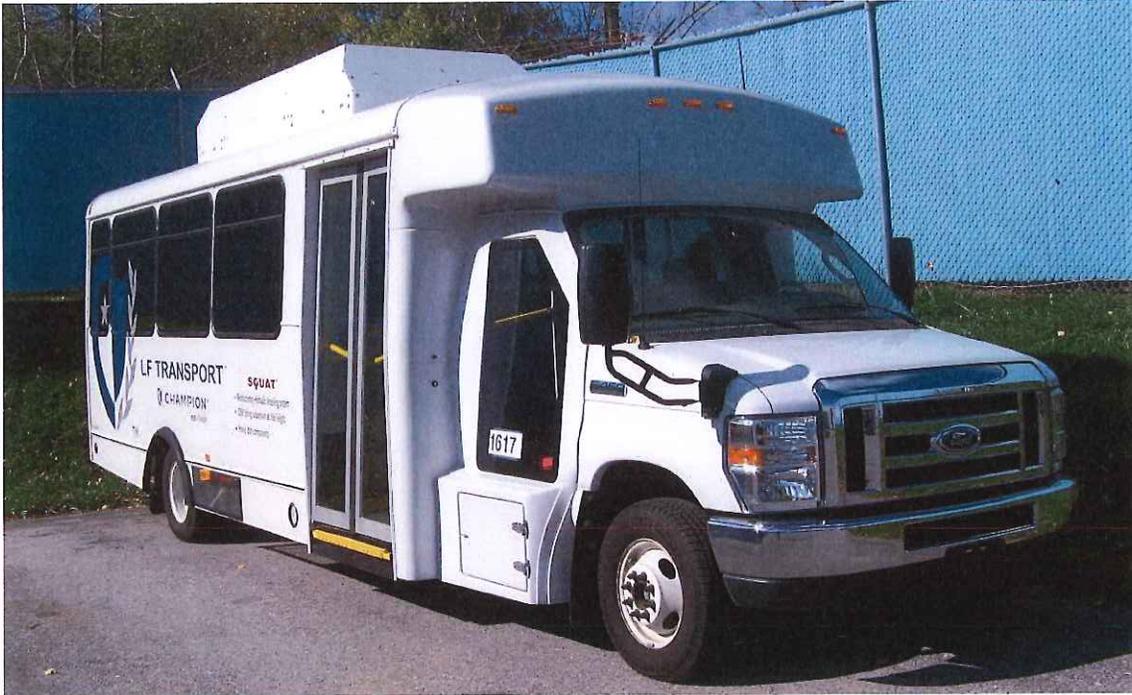
**CHAMPION BUS, INC.  
MODEL LF TRANSPORT**

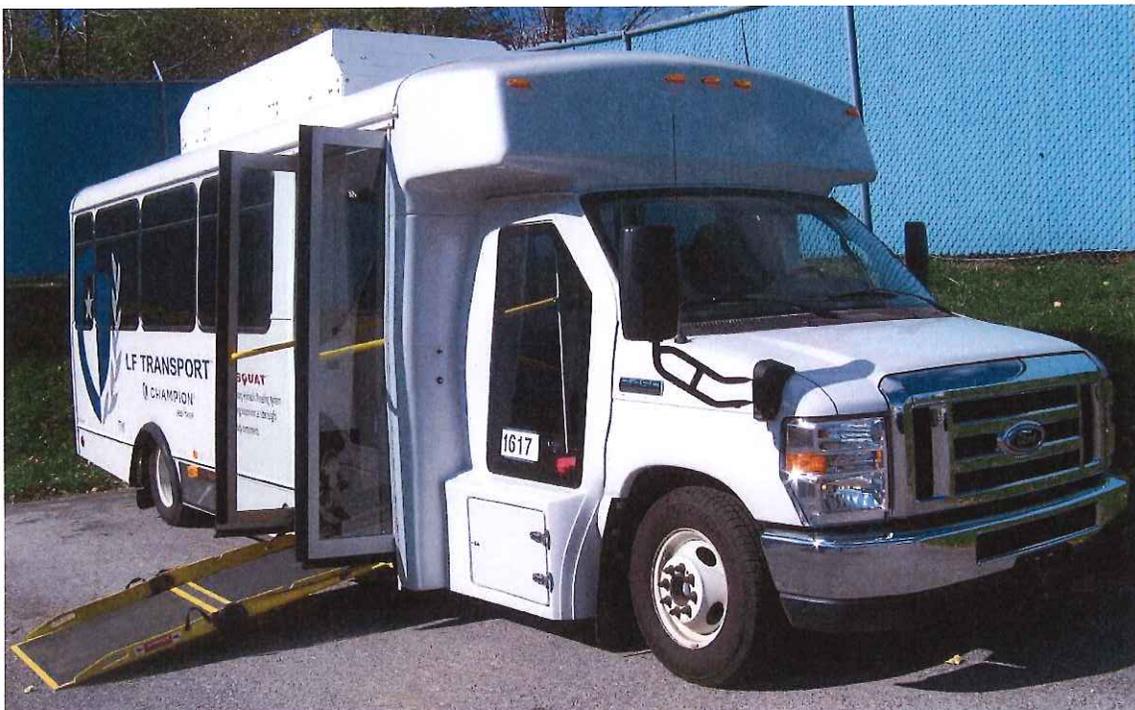
**EQUIPPED WITH A BRAUNABILITY  
MODEL BF 3462Y-2 ADA ACCESSIBLE RAMP**

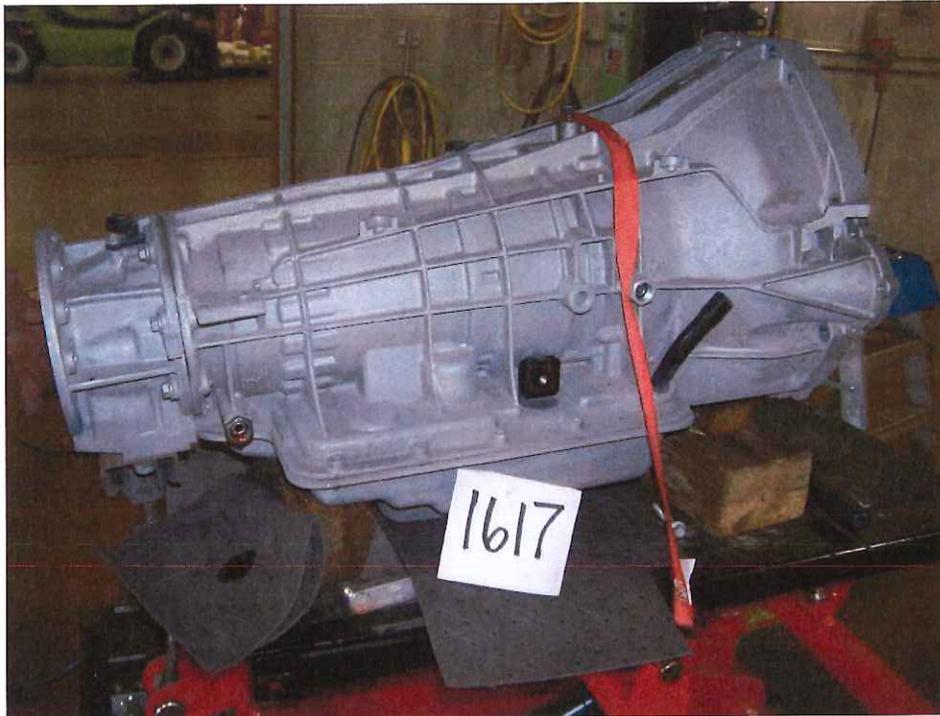
**TRANSMISSION REMOVAL AND REPLACEMENT  
(5.5 LABOR HOURS)**

At the end of the test, the remaining items on the list were removed and replaced. The transmission assembly took 5.50 labor-hours (two persons 2.75 hrs) to remove and replace. The time required for repair/replacement of the four remaining components is given on the following Repair and/or Replacement Form.

<b>Subsystem</b>	<b>Replacement Time</b>
Transmission	5.50 labor hours
Wiper Motor	1.00 labor hours
Starter	0.50 labor hour
Alternator	1.50 labor hours
Batteries	0.50 labor hours

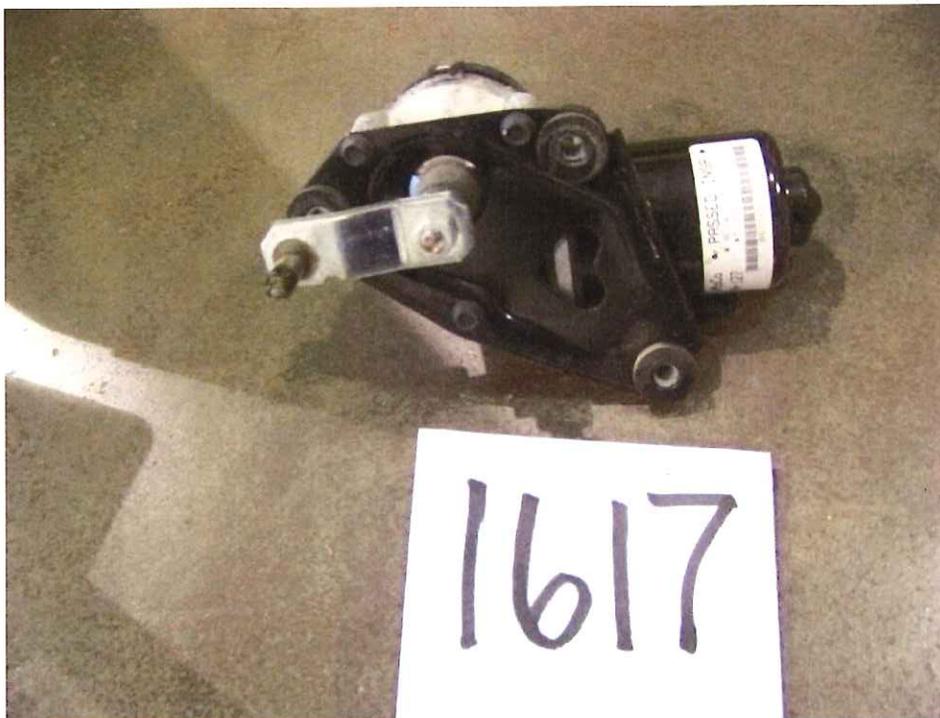
**WIPER MOTOR REMOVAL AND REPLACEMENT  
(1.0 LABOR HOURS)**

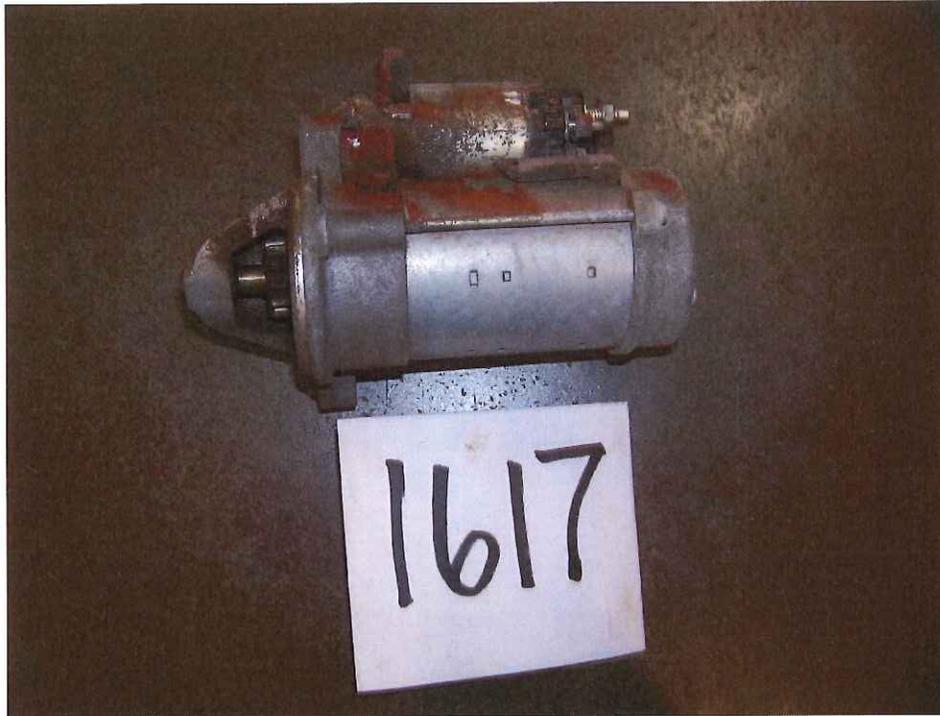
**STARTER REMOVAL AND REPLACEMENT  
(0.5 LABOR HOUR)**

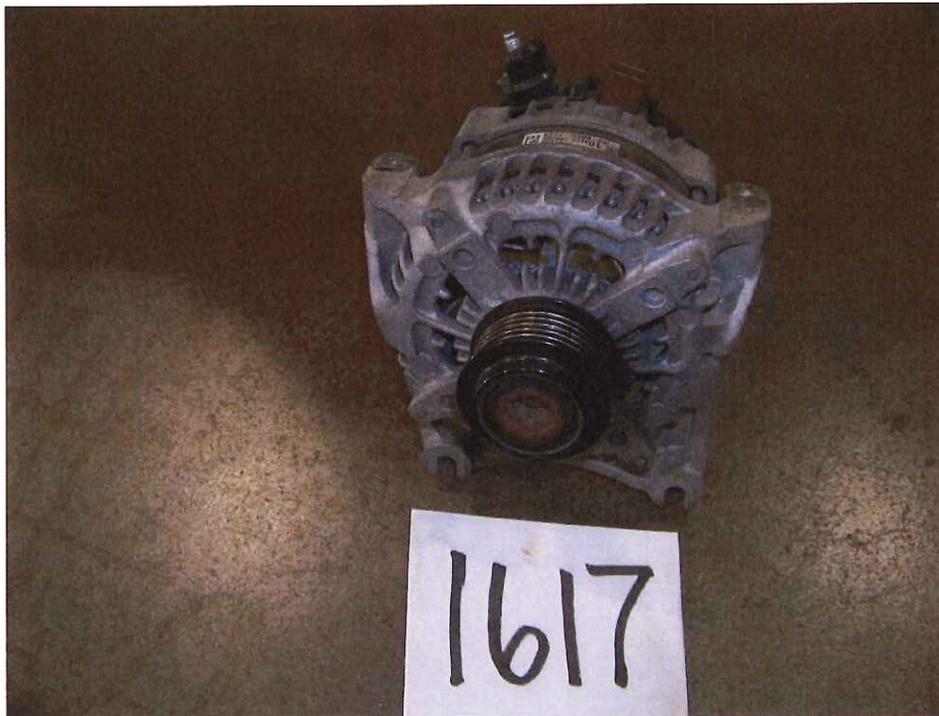
**ALTERNATOR REMOVAL AND REPLACEMENT  
(1.5 LABOR HOURS)**

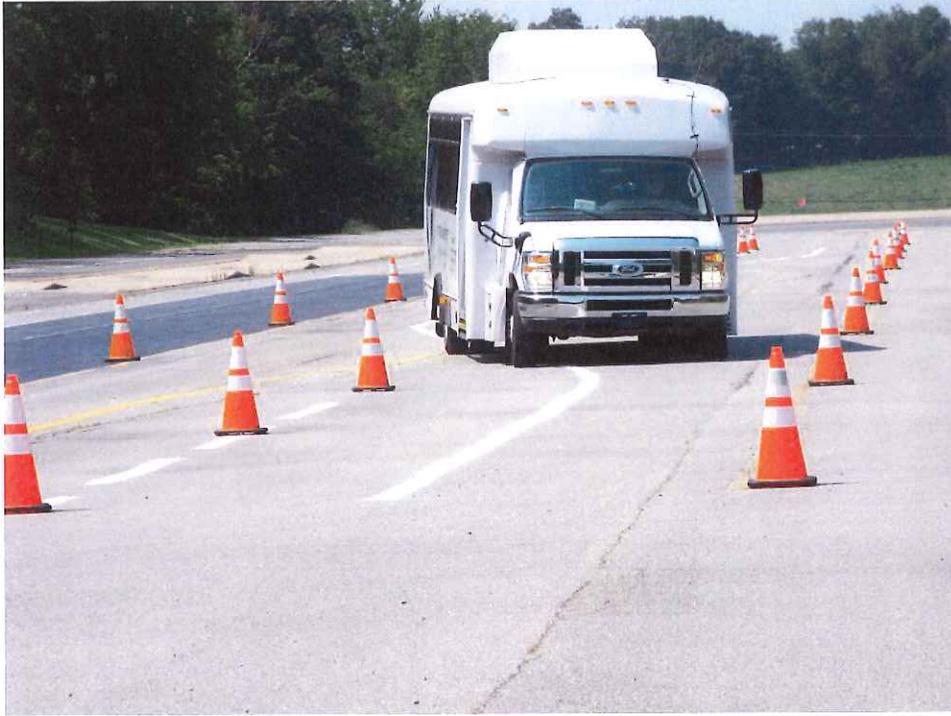
**RIGHT - HAND APPROACH**

<b>SAFETY TEST: DOUBLE LANE CHANGE</b>	
Maximum safe speed tested for double-lane change to left	45 mph
Maximum safe speed tested for double-lane change to right	45 mph
<b>Comments of the position of the bus during the lane change:</b> The bus maintained a safe profile throughout the test.	
<b>Comments of the tire/ground contact patch:</b> The bus maintained tire/ground contact throughout the test.

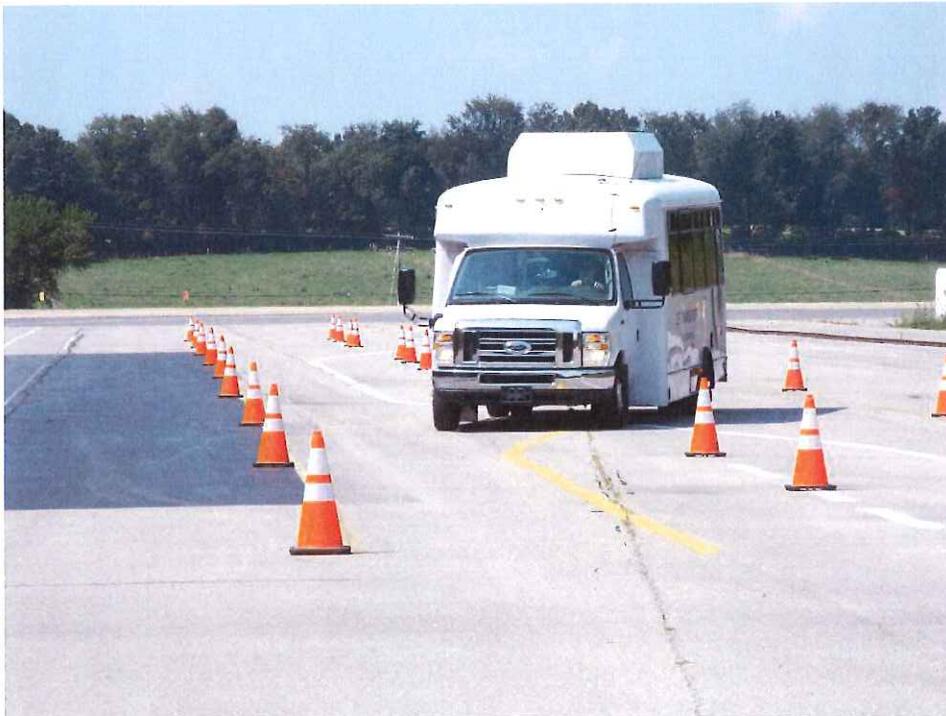
**LEFT - HAND APPROACH**

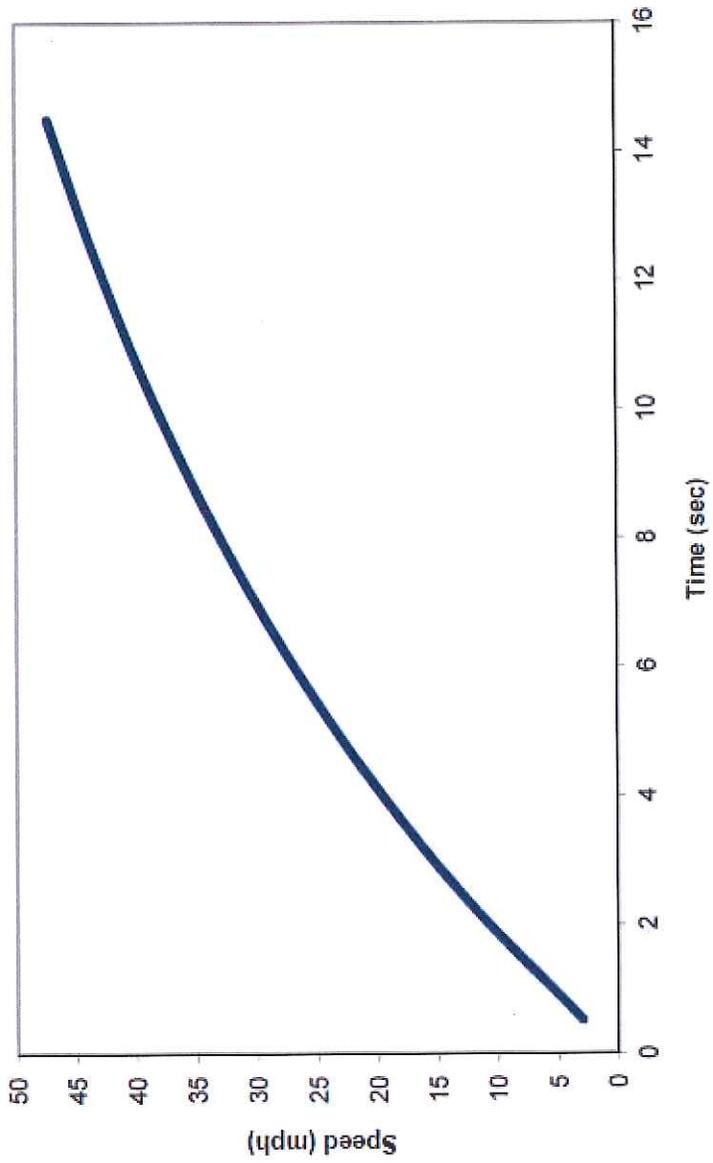
Velocity vs. Time  
Champion Bus, Inc. Bus #1617

NOTE : Gradeability results were calculated from performance  
 ----- test data. Actual sustained gradeability performance  
 for vehicles equipped with auto transmission may be  
 lower than the values indicated here.

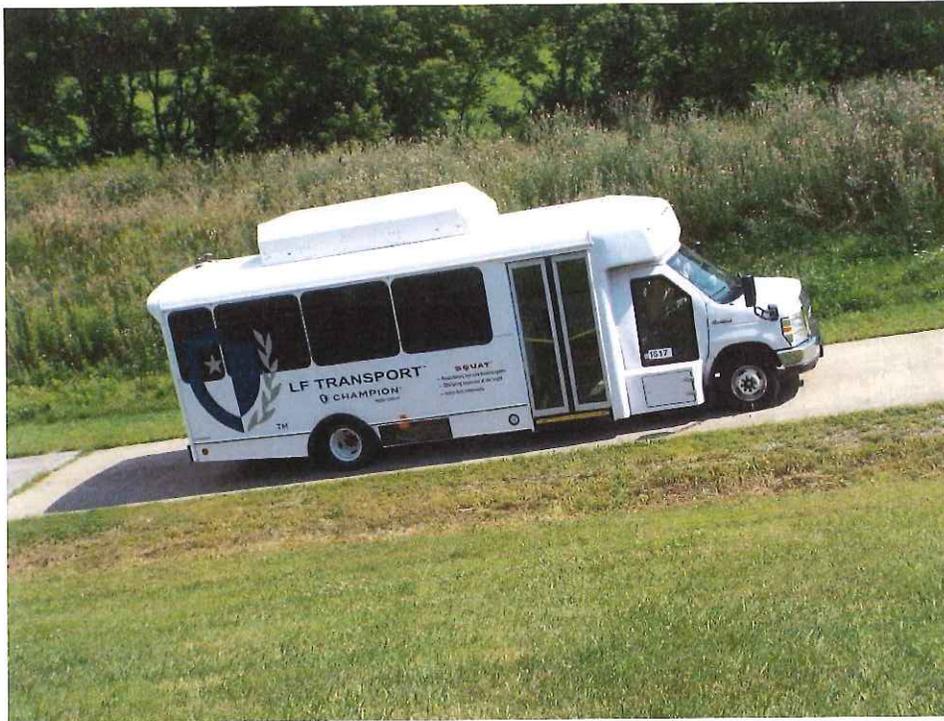
**PARKING BRAKE TEST  
PARKING BRAKE HELD FOR 5 MINUTES IN  
BOTH 20% UP AND 20% DOWN POSITIONS**

PARKING BRAKE (Fully Loaded) – GRADE HOLDING						
Vehicle Direction	Attempt	Hold Time (min)	Slide (in)	Roll (in)	Did Hold	No Hold
Front up	1	5:00	0	0	✓	
	2	N/A	N/A	N/A	N/A	N/A
	3	N/A	N/A	N/A	N/A	N/A
Front down	1	5:00	0	0	✓	
	2	N/A	N/A	N/A	N/A	N/A
	3	N/A	N/A	N/A	N/A	N/A

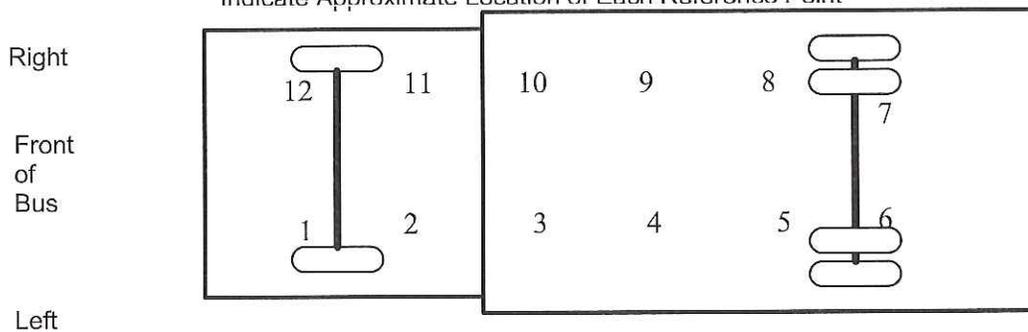
Indicate Approximate Location of Each Reference Point

Reference Point No.	A (in) Original Height	B (in) Loaded Height	B-A (in) Loaded Deflection	C (in) Unloaded Height	C-A (in) Permanent Deflection
1	0	-.074	-.074	-.005	-.005
2	0	.078	.078	.002	.002
3	0	.148	.148	.007	.007
4	0	.141	.141	.007	.007
5	0	.137	.137	.046	.046
6	0	.238	.238	.026	.026
7	0	.215	.215	.007	.007
8	0	.095	.095	.015	.015
9	0	.139	.139	.015	.015
10	0	.113	.113	.011	.011
11	0	.053	.053	.006	.006
12	0	-.078	-.078	-.003	-.003

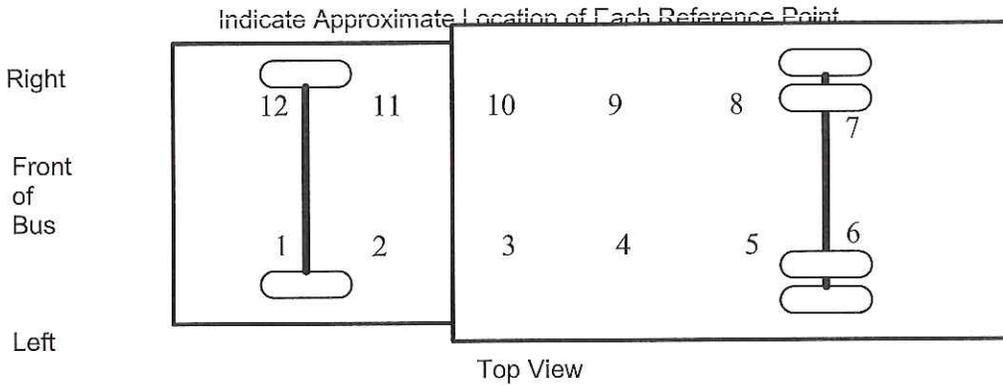
Reference Point No.	A (in) Original Height	B (in) Loaded Height	B-A (in) Loaded Deflection	C (in) Unloaded Height	C-A (in) Permanent Deflection
1	-.005	-.079	-.074	-.009	-.004
2	.002	.081	.079	.004	.002
3	.007	.153	.146	.010	.003
4	.007	.146	.139	.011	.004
5	.046	.171	.125	.050	.004
6	.026	.238	.212	.029	.003
7	.007	.211	.204	.009	.002
8	.015	.104	.089	.019	.004
9	.015	.149	.134	.018	.003
10	.011	.120	.109	.014	.003
11	.006	.056	.050	.008	.002
12	-.003	-.083	.080	-.006	-.003

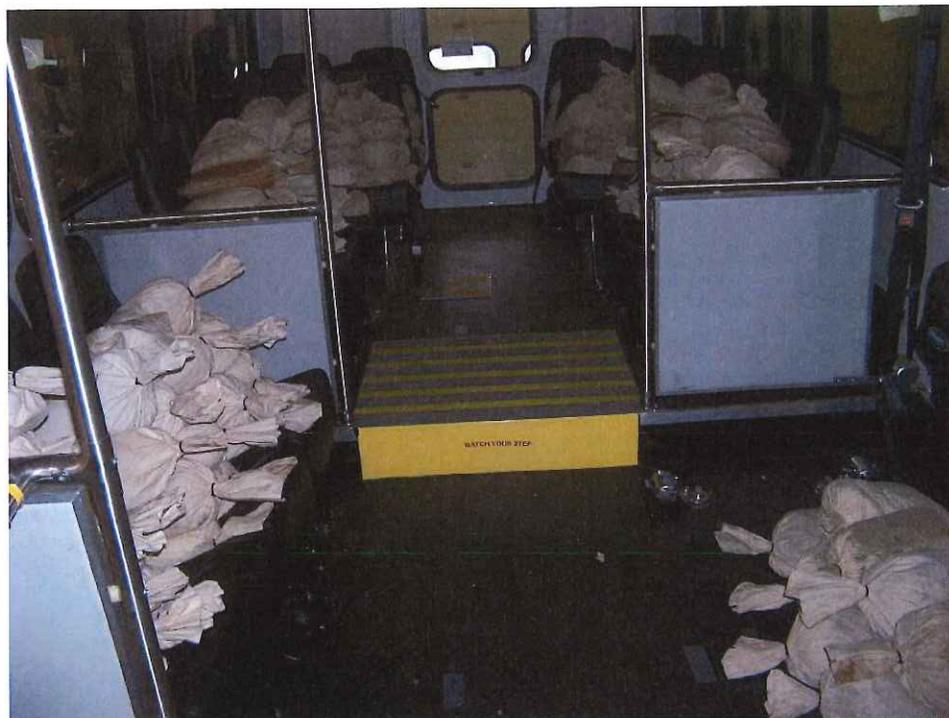
**BUS LOADED TO 2.5 TIMES GVL  
(7,200 lb.)**

The Shakedown Test produced a maximum final loaded deflection of 0.212 inches with a permanent set ranging between -0.004 to 0.004 inches under a distributed static load of 7,200 lb. The Distortion Test was completed with all subsystems, doors and escape mechanisms operating properly. No water leakage was observed throughout the test. All subsystems operated properly.

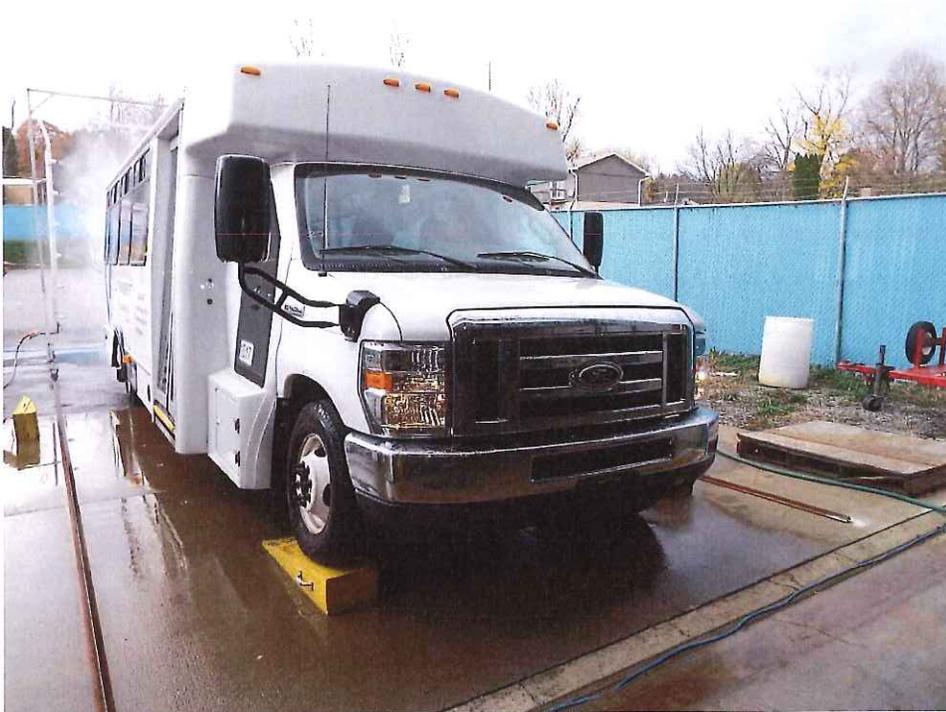
**RIGHT FRONT WHEEL SIX INCHES HIGHER**

Comments
Windows	No Deficiencies
Front Doors	No Deficiencies
Rear Doors	No Deficiencies
Escape Mechanisms/ Roof Vents	No Deficiencies
Engine	No Deficiencies
ADA Accessible Device/ Special Seating	No Deficiencies
Undercarriage	No Deficiencies
Service Doors	No Deficiencies
Body	No Deficiencies
Windows/ Body Leakage	No Deficiencies
Steering Mechanism	No Deficiencies

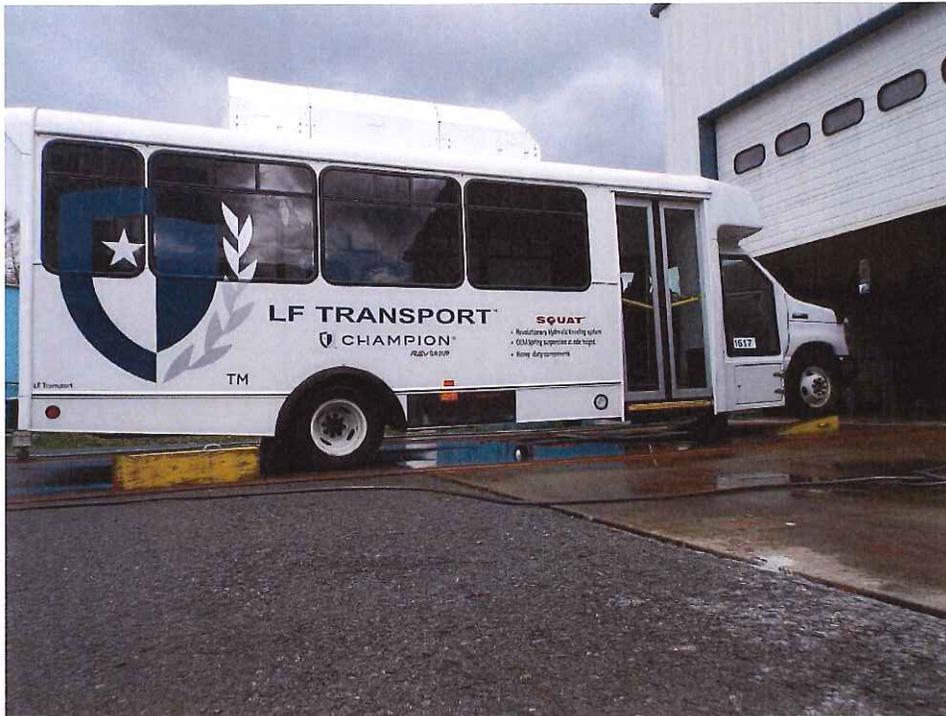
**RIGHT REAR WHEEL SIX INCHES LOWER**

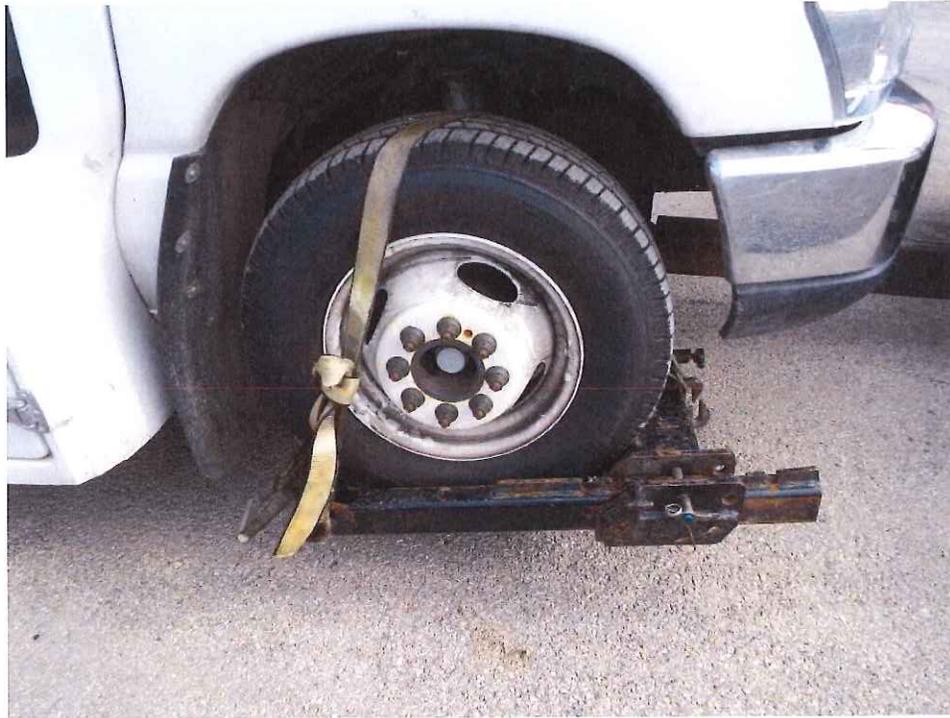
**TOWING INTERFACE**

<b>Inspect tow equipment-bus interface.</b>
<b>Comments:</b> A safe and adequate connection was made between the tow equipment and bus.
<b>Inspect tow equipment-wrecker interface.</b>
<b>Comments:</b> A safe and adequate connection was made between the tow equipment and the wrecker.
<b>Towing Comments:</b> A front-lift tow was performed incorporating a hydraulic under lift wrecker.
<b>Description and location of any structural damage:</b> None Noted
<b>General Comments:</b> None Noted

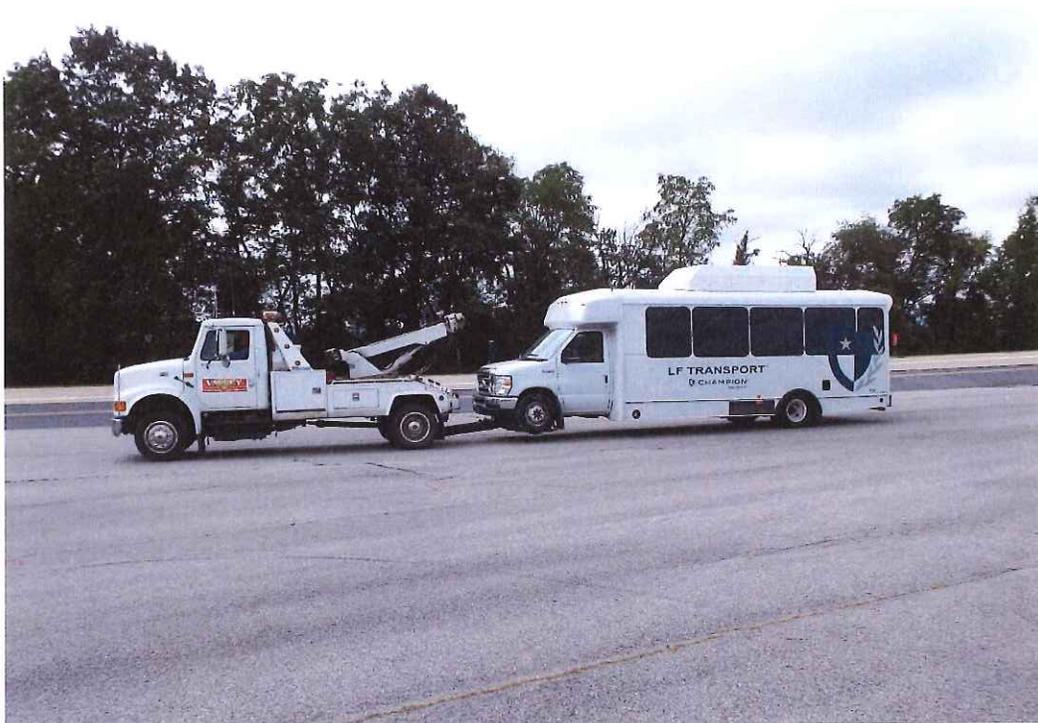
**TEST BUS IN TOW**

The test bus submitted for testing was not equipped with any type of tow eyes or tow hooks. Therefore, the static towing test was not performed. The Dynamic Towing Test was performed by means of a front-lift tow. The towing interface was accomplished using a hydraulic under-lift wrecker. The bus was towed without incident and no damage resulted from the test. The Jacking and Hoisting Tests were also performed without incident. The bus was found to be stable on the jack stands, and the minimum jacking clearance observed with a tire deflated was 7.0 inches.

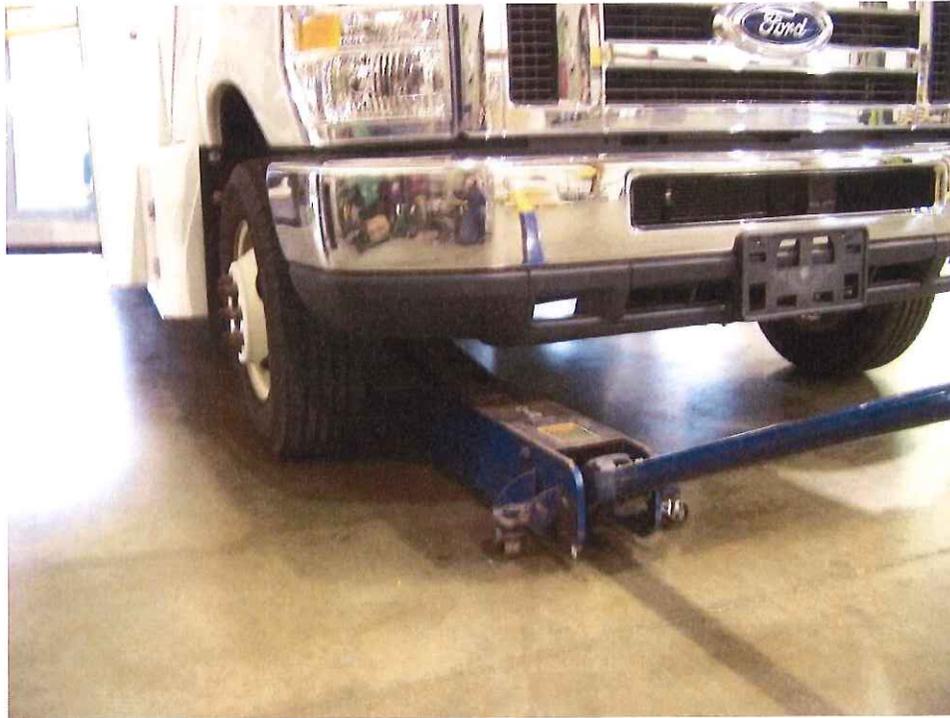
**JACK UNDER THE FRONT AXLE**

Deflated Tire	Jacking Pad Clearance Body/Frame (in)	Jacking Pad Clearance Axle/Suspension (in)	Comments
Right front	9.4 " I 7.0 " D	11.8 " I 8.9 " D	Body & Axle
Left front	14.8 " I 12.1 " D	7.7 " I 8.9 " D	Body & Axle
Right rear—outside	11.7 " I 11.1 " D	9.3 " I 8.9 " D	Body & Suspension
Right rear—both	11.7 " I 8.5 " D	9.3 " I 6.8 " D	Body & Suspension
Left rear—outside	12.9 " I 12.4 " D	9.8 " I 9.4 " D	Body & Suspension
Left rear—both	12.9 " I 10.4 " D	9.8 " I 7.8 " D	Body & Suspension
Right middle or tag—outside	N/A	N/A	N/A
Right middle or tag—both	N/A	N/A	N/A
Left middle or tag—outside	N/A	N/A	N/A
Left middle or tag—both	N/A	N/A	N/A
<b>Additional comments of any deformation or difficulty during jacking:</b>			
None noted.

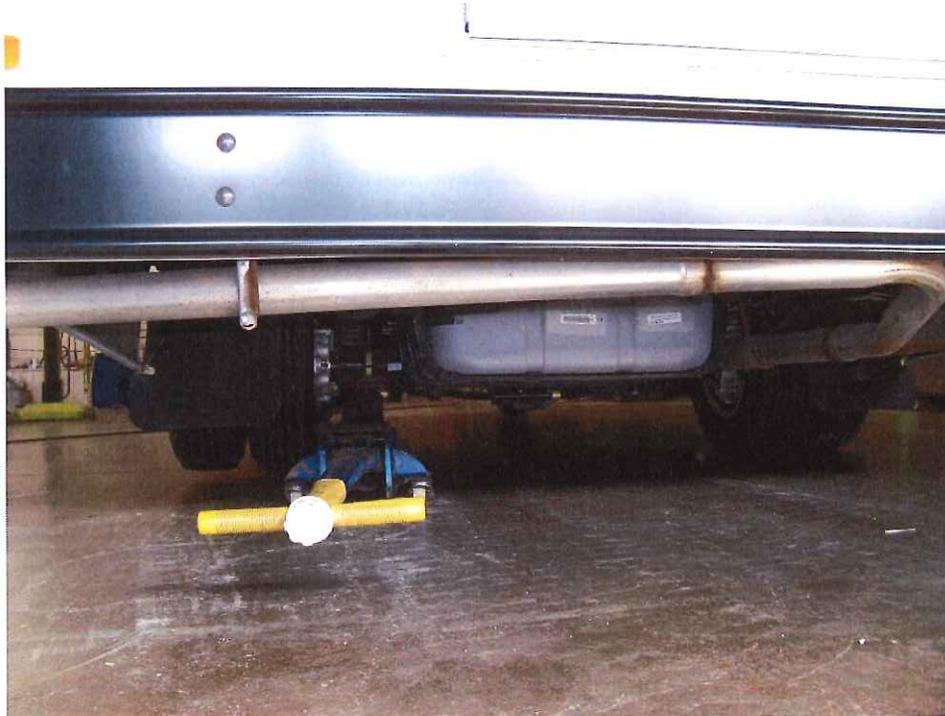
**BUS LIFTED – REAR AXLE**

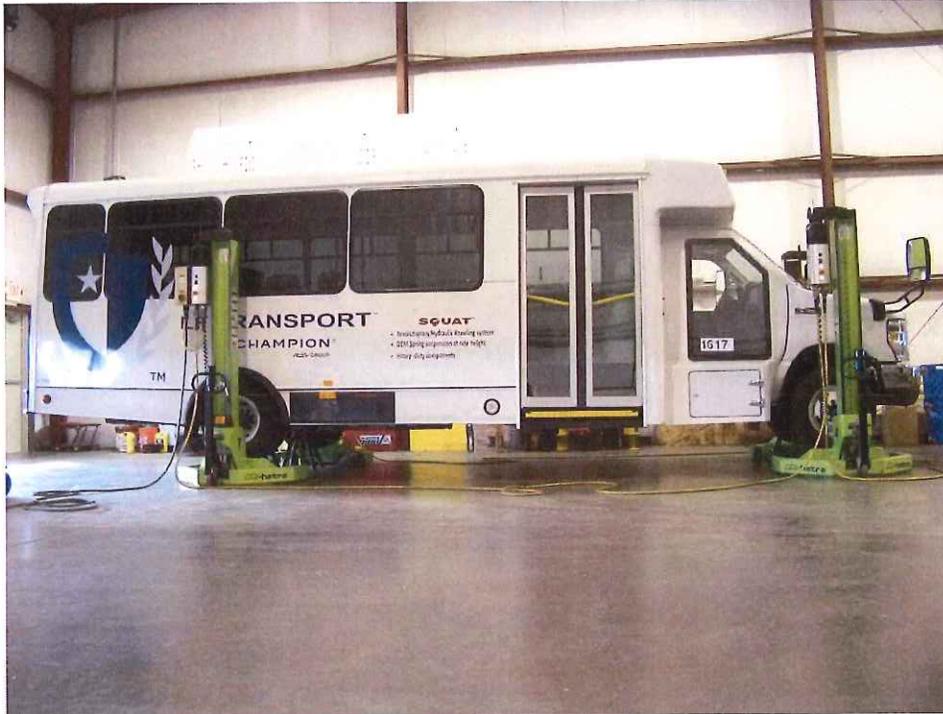
**TEST BUS ON LIFTS**

<b>Comments of any structural damage to the jacking pads or axles while both the front wheels are supported by the jack stands:</b>
None noted.
<b>Comments of any structural damage to the jacking pads or axles while both the rear wheels are supported by the jack stands:</b>
None noted.
<b>Comments of any structural damage to the jacking pads or axles while both the tag axle wheels are supported by the jack stands:</b>
N/A
<b>Comments of any structural damage to the jacking pads or axles while both the front and rear wheels are supported by the jack stands:</b>
None noted.
<b>Comments of any problems or interference placing wheel hoists under wheels:</b>
None noted.

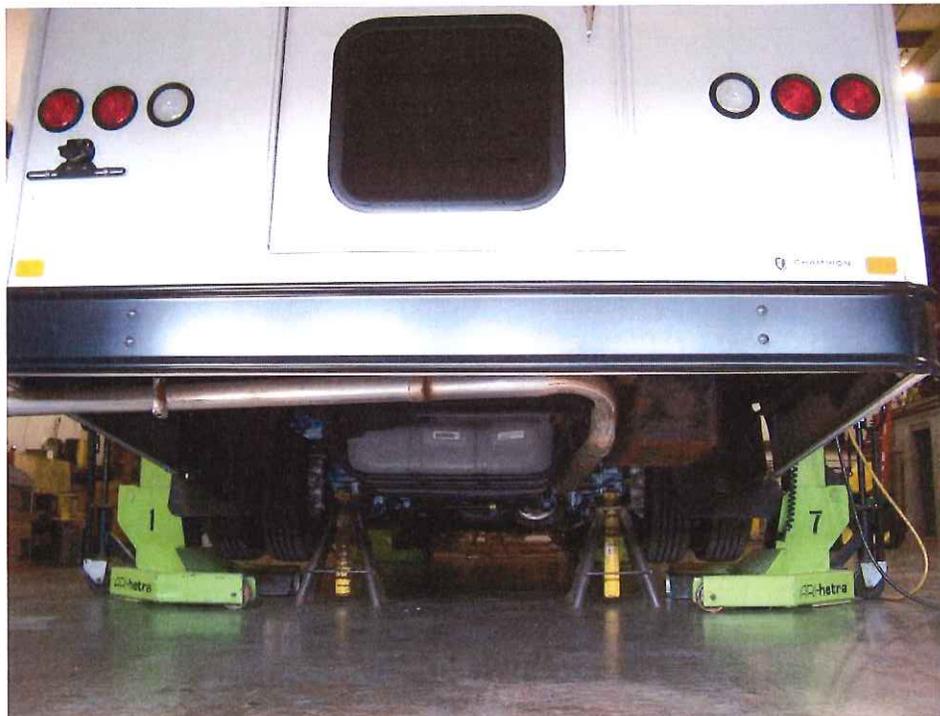
**TEST BUS ON JACK STANDS**

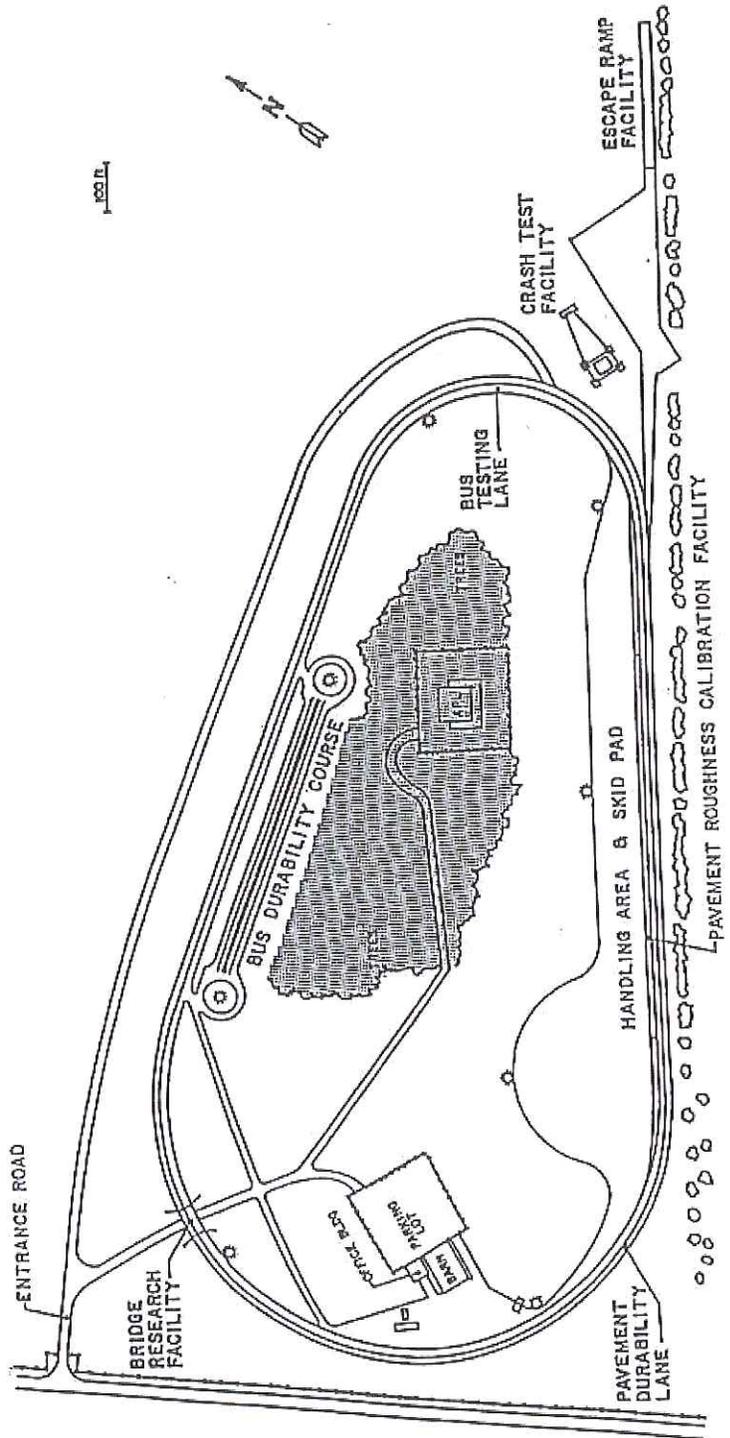
# “PLAN VIEW OF PENN STATE BUS TESTING AND RESEARCH FACILITY”

BUS TESTING AND RESEARCH TEST TRACK  
UNIVERSITY PARK, PA

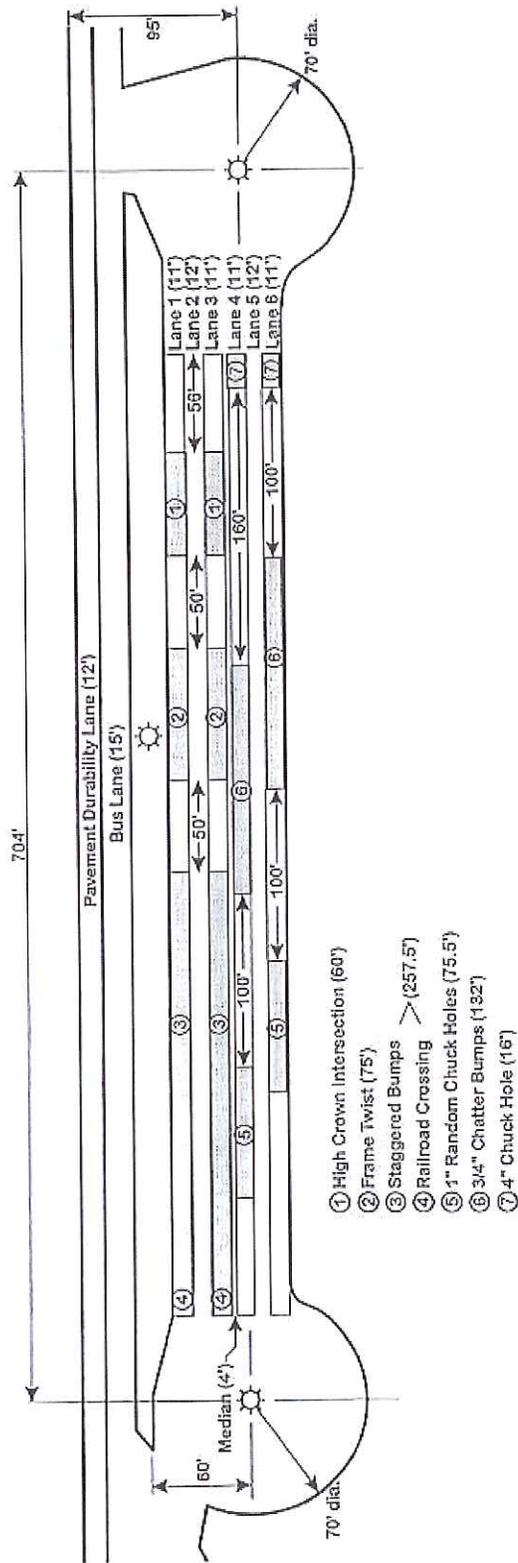
Plan View  
**Vehicle Durability Test Track**  
 The Pennsylvania Transportation Institute  
 Penn State

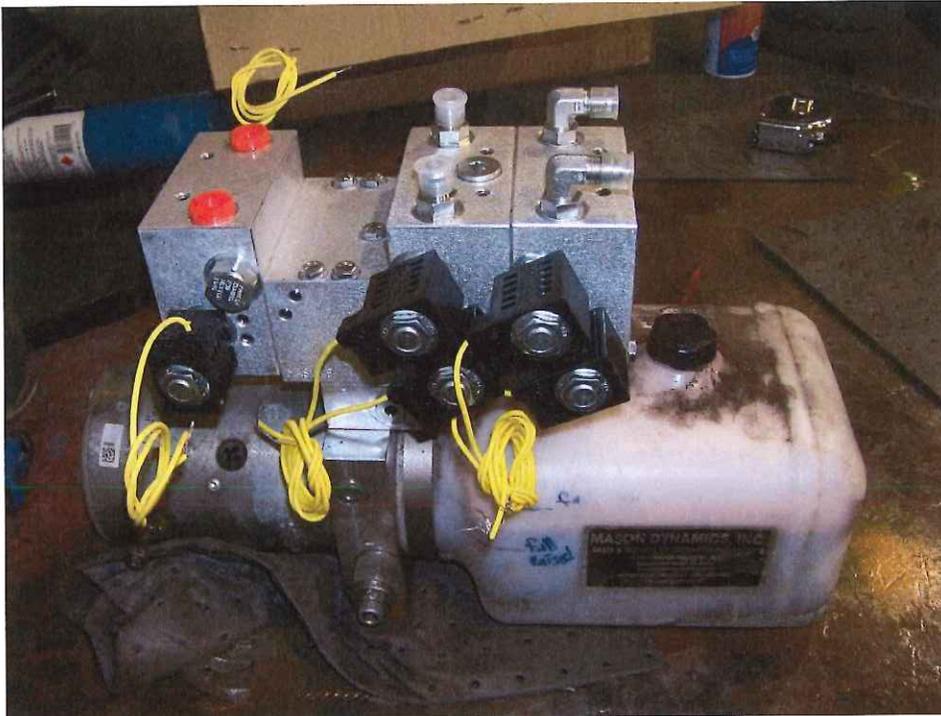
**HYDRAULIC PUMP REPLACED  
378 TEST MILES**

DATE	TEST MILES	ISSUE	ACTION	LABOR HOURS	DOWN TIME
10-30-17	5,349	Left, front tire has bolt in tread.	Removed bolt installed tire plug. Rotated tire to left, rear.	1.00	1.00
11-08-17	7,060	Exhaust pipe behind catalytic converter has two grooves worn from rubbing on cross beam.	Exhaust pipe was welded to fill grooves and a plate was added to the top of the cross beam to prevent additional wear.	1.00	1.00
11-09-17	7,245	Bolts are broken on front hanger of both rear springs.	Replaced bolts.	4.00	2.00

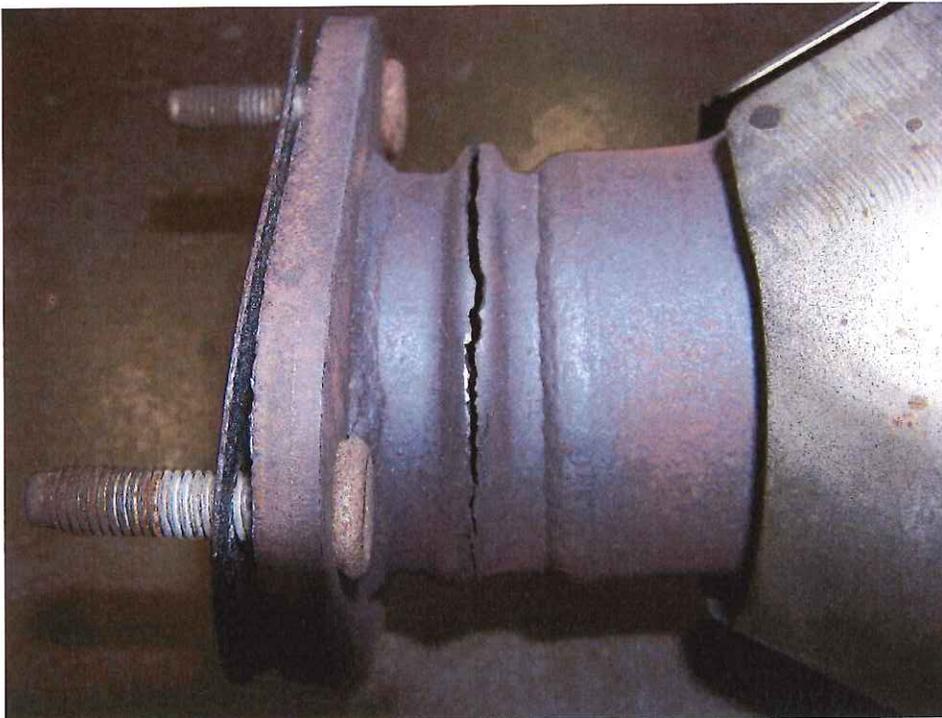
**CATALYTIC CONVERTER CRACKED  
1,414 TEST MILES**

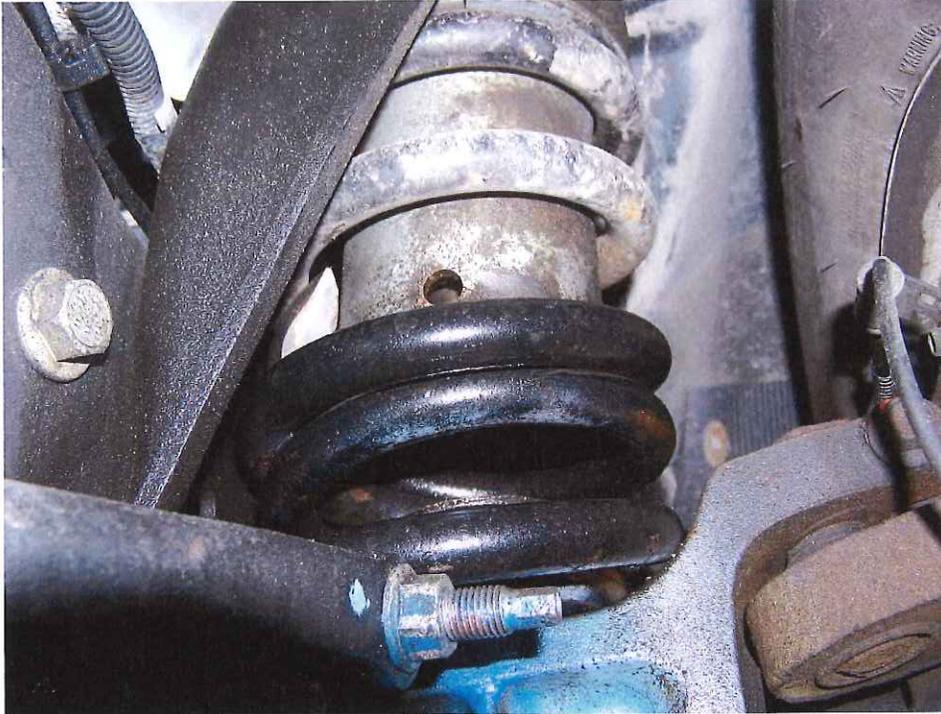
**LEFT, FRONT COIL SPRING IS BROKEN  
1,620 TEST MILES**

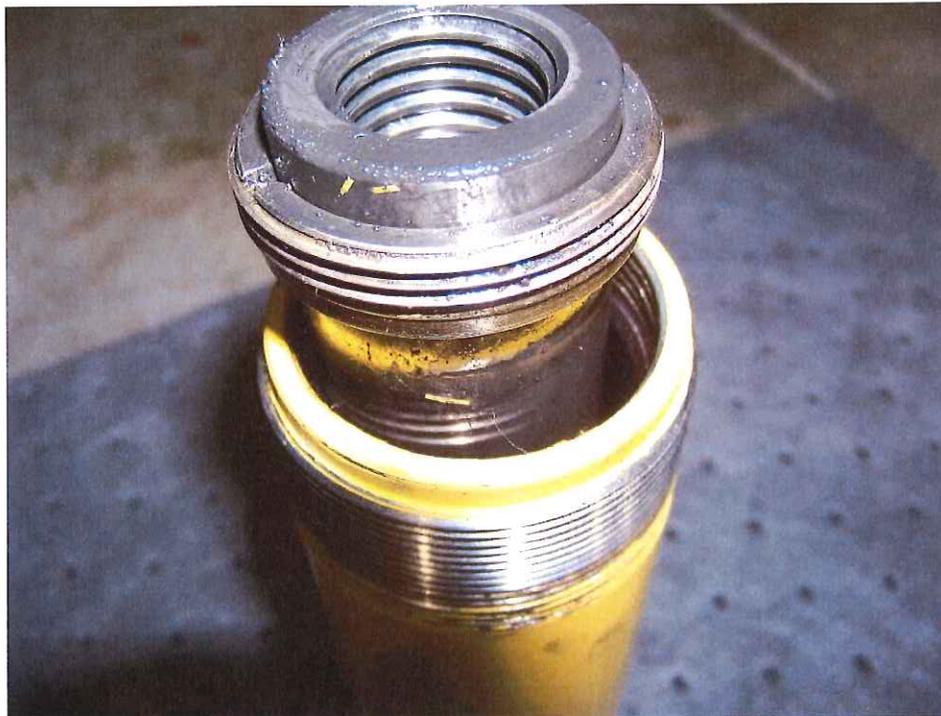
**LEFT, FRONT HYDRAULIC KNEELING CYLINDER  
1,620 TEST MILES**

The Reliability section compiles failures that occurred during Structural Durability Testing. Breakdowns are classified according to subsystems. The data in this section are arranged so that those subsystems with more frequent problems are apparent. The problems are also listed by class as defined in Section 2. The test bus encountered no Class 1, but 10 Class 2 failures. Of the 22 reported failures, 11 were Class 3 and one was Class 4. The hydraulic kneeling SQUAT system suffered multiple breakdowns

during the durability tests and was replaced with a Ford OEM suspension at 4,801 test miles at the beginning of the curb weight segment.

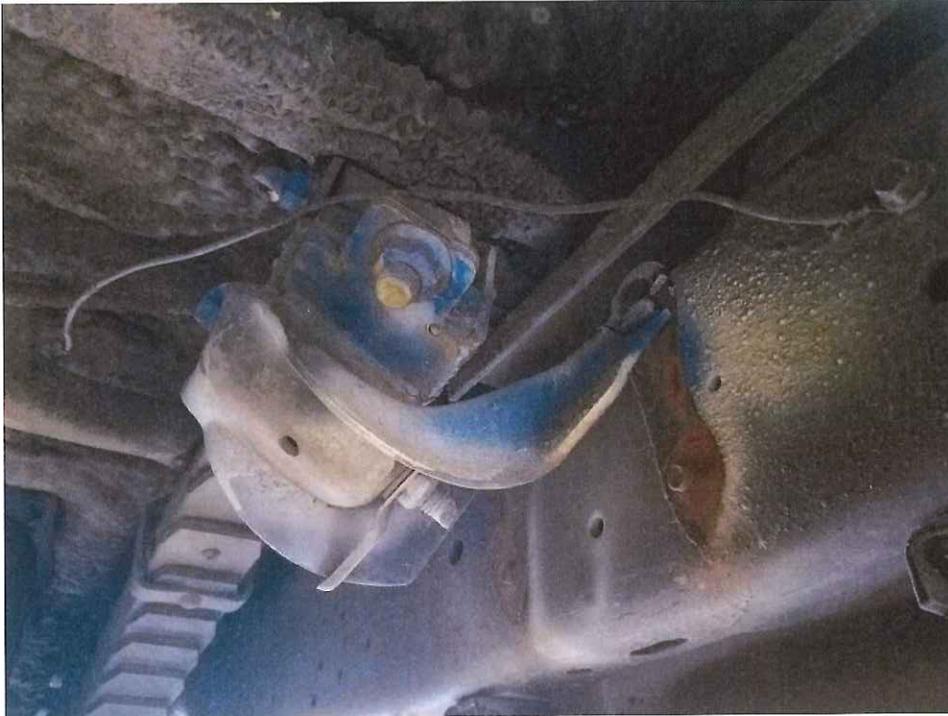
**LEFT, REAR SPRING HANGER FAILURE  
3,066 TEST MILES**
