## REQUEST FOR TRANSIT VEHICLE PRICE QUOTE (RFQ)

VENDOR (Business Name): SCHETKY NW SALES

Agency: Yamhill County Transit Area Date: 9/2//2021  
Contact Person: Cynthia Thompson Phone: 503-995-7965  
Email Address: [Thompsonc@co.yamhill.or.us](mailto:Thompsonc@co.yamhill.or.us)

Report Number: LTI-BT-R1617

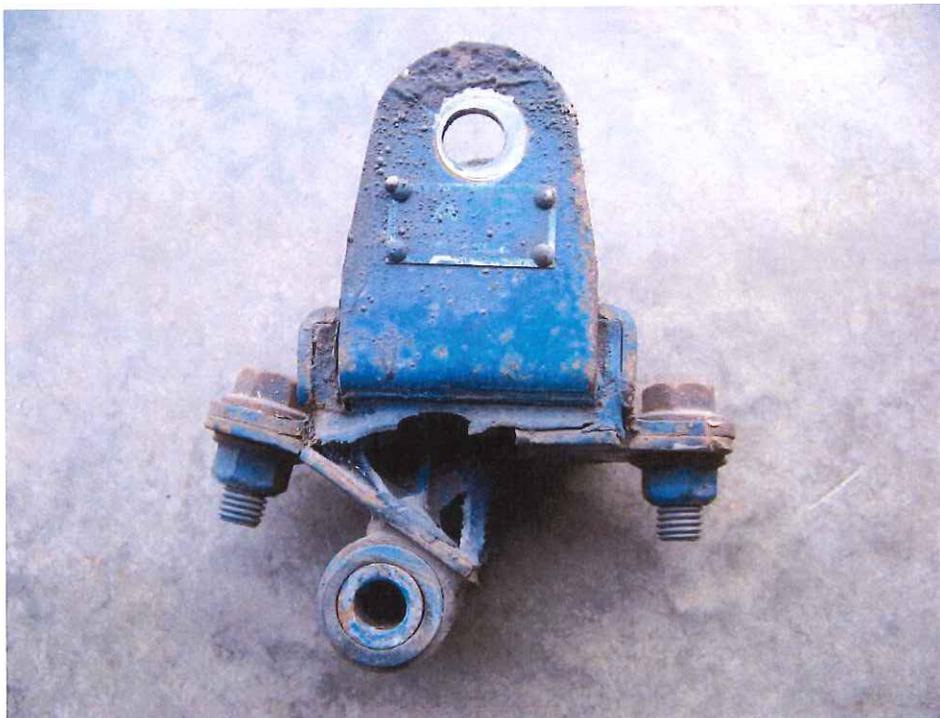
**RIGHT, REAR SPRING SHACKLE  
4,801 TEST MILES**

during the durability tests and was replaced with a Ford OEM suspension at 4,801 test miles at the beginning of the curb weight segment.

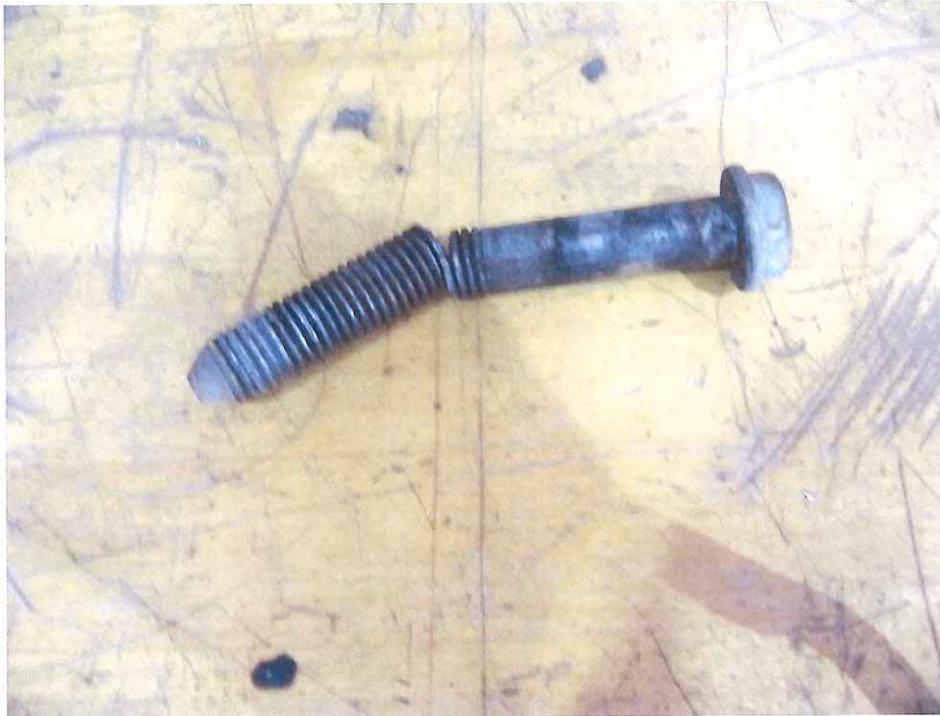
**FRONT LEAF SPRING BOLTS ON REAR AXLE REPLACED X 2  
7,245 TEST MILES**

DATE	TEST MILES	ISSUE	ACTION	LABOR HOURS	DOWN TIME
10-30-17	5,349	Left, front tire has bolt in tread.	Removed bolt installed tire plug. Rotated tire to left, rear.	1.00	1.00
11-08-17	7,060	Exhaust pipe behind catalytic converter has two grooves worn from rubbing on cross beam.	Exhaust pipe was welded to fill grooves and a plate was added to the top of the cross beam to prevent additional wear.	1.00	1.00
11-09-17	7,245	Bolts are broken on front hanger of both rear springs.	Replaced bolts.	4.00	2.00

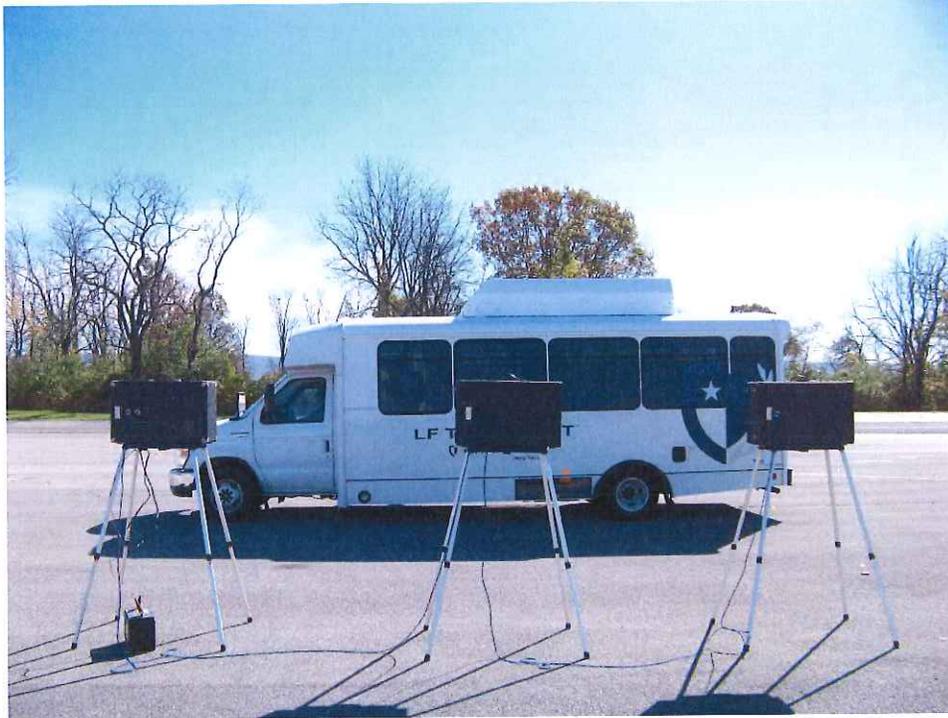
**TEST BUS SET-UP FOR 80 dB(A)  
INTERIOR NOISE TEST**

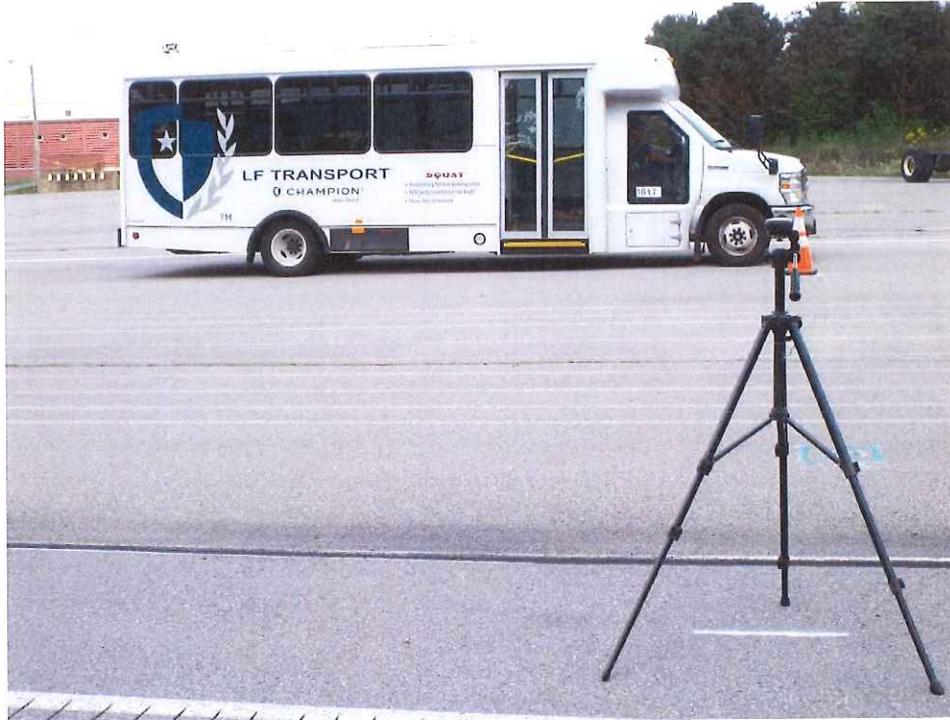
**TEST BUS SET-UP FOR EXTERIOR NOISE TEST**

Bus Number: 1617		Date: 08-08-17	
Personnel: T.S. & S.R.			
Temperature (°F): 74		Humidity (%): 50	
Wind Speed (mph): 6		Wind Direction: NW	
Barometric Pressure (in.Hg): 30.00			
Initial Sound Level Meter Calibration: 93.9 dB(A)			
Exterior Ambient Noise Level: 44.4 dB(A)			
Accessories and Air Conditioning ON			
Throttle Position	Engine RPM	Curb (Right) Side dB(A)	Street (Left) Side dB(A)
		Measured	Measured
Low Idle	620	47.6	47.9
High Idle	1500	60.7	57.7
Wide Open Throttle	3459	69.0	68.2
Accessories and Air Conditioning OFF			
Throttle Position	Engine RPM	Curb (Right) Side dB(A)	Street (Left) Side dB(A)
		Measured	Measured
Low Idle	625	46.9	49.2
High Idle	1500	59.0	61.9
Wide Open Throttle	3460	68.3	68.0
Final Sound Level Meter Calibration Check: 93.9 dB(A)			
<b>Comments:</b> None noted

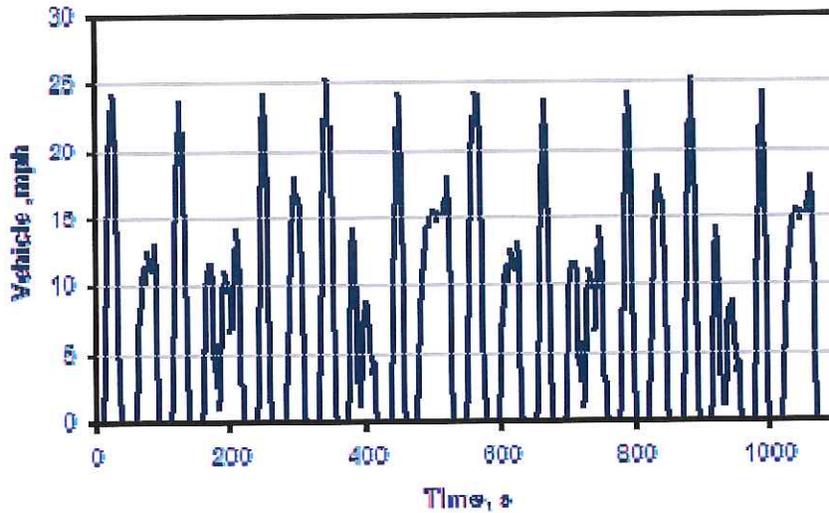
**Figure 1.** Manhattan Driving Cycle (duration 1089 sec, Maximum speed 25.4mph, average speed 6.8mph)

The emissions test will be performed as soon as permissible after the completion of the GVW portion of the structural durability test. The driving cycles are the Manhattan cycle, a low average speed, highly transient urban cycle (Figure 1), the Orange County Bus Cycle which consists of urban and highway

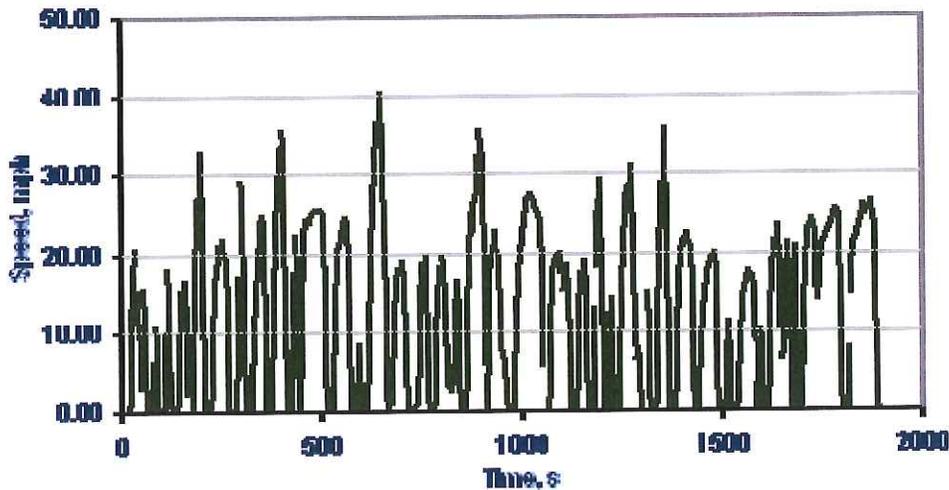
**Figure 2.** Orange County Bus Cycle (Duration 1909 Sec, Maximum Speed 41mph, Average Speed 12mph)

driving segments (Figure 2), and the EPA UDDS Cycle (Figure 3). An emissions test will comprise of two runs for the three different driving cycles, and the average value will be reported. Test results reported will include the average grams per mile value for each of the gaseous emissions for gasoline buses, for all the three driving cycles. In addition, the particulate matter emissions are included for diesel buses, and non-methane hydrocarbon emissions (NMHC) are included for CNG buses. Testing is performed in accordance with EPA CFR49, Part 1065 and SAE J2711 as practically determined by the FTA Emissions Testing Protocol developed by West Virginia University and Penn State University.

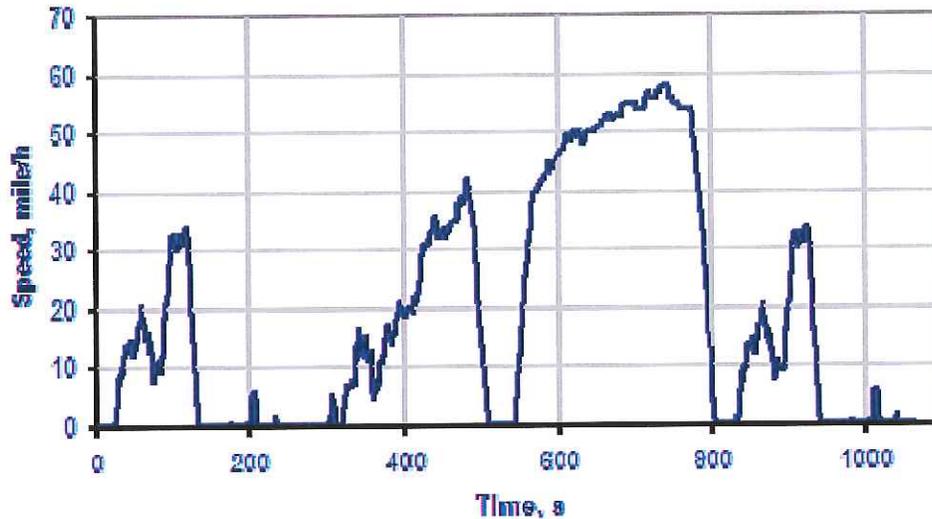
**Figure 3.** HD-UDDS Cycle (duration 1060seconds, Maximum Speed 58mph, Average Speed 18.86mph)
